PHASE I MILESTONE INSPECTION

Santa Maria II Condominium Association, Inc.

7317 & 7327 Estero Blvd.

Report Date May 15, 2024

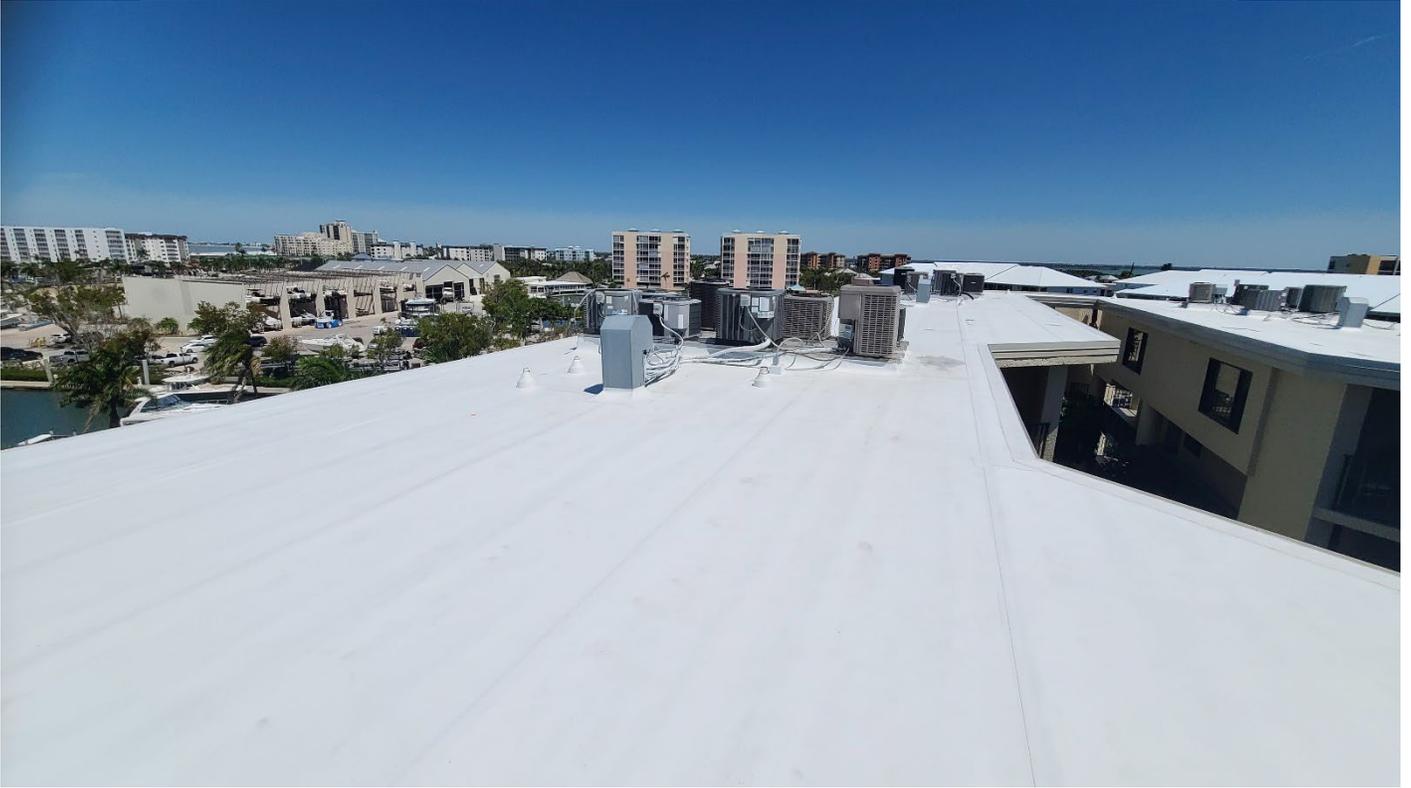
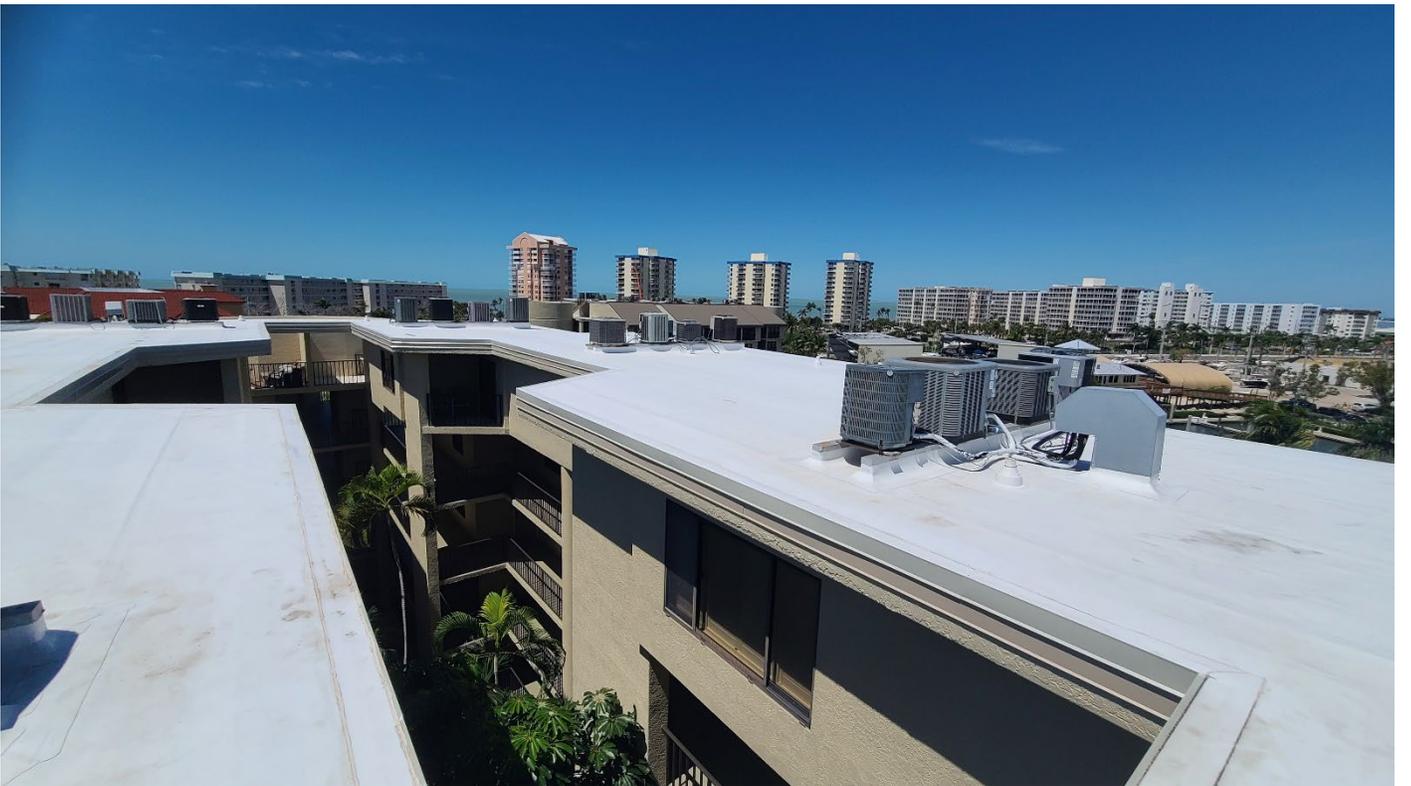
(3rd level) at the building's center. These areas are also covered with TPO system. The current roof was installed in November 2023 as reported. The existing roofing condition is good.

Photograph 5: Building Roof, Current Condition is Good.

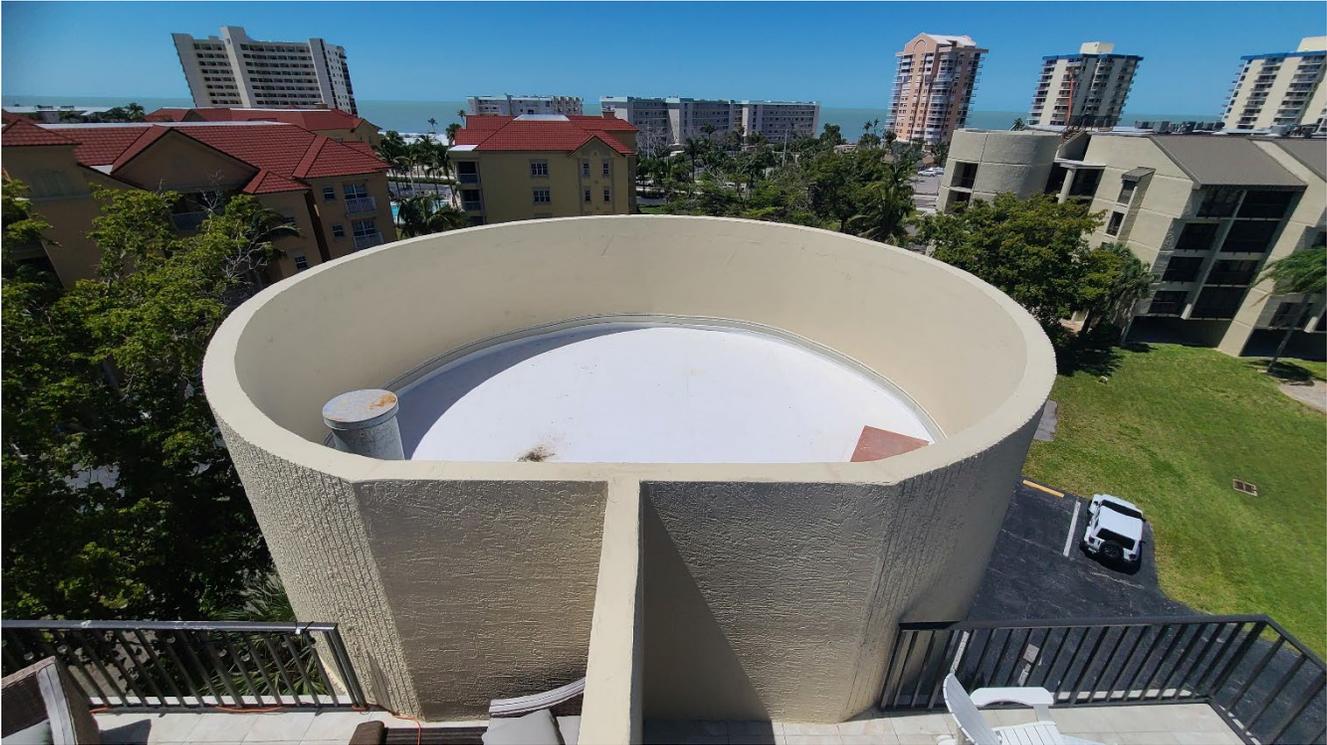
Photograph 6: Stairwell Roof, Current Condition is Good.

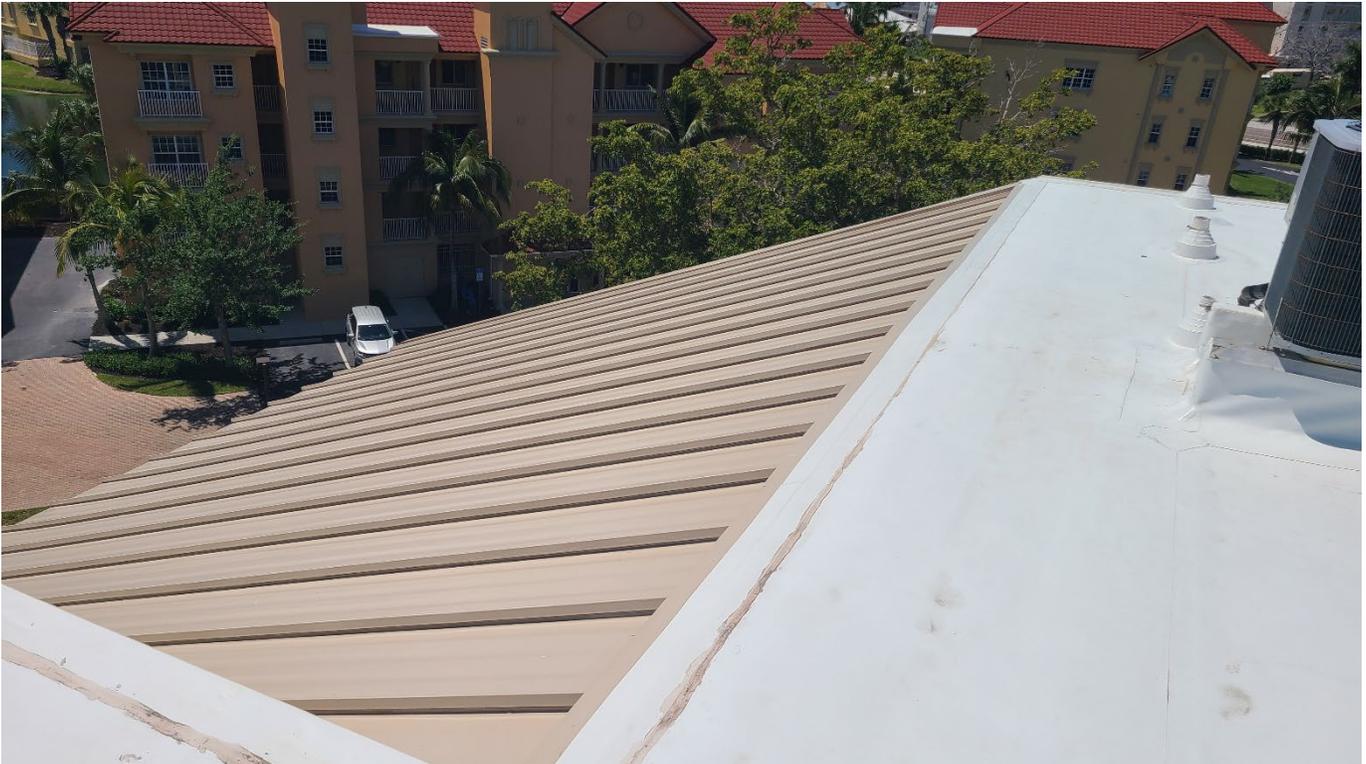
Photograph 7: Metal Mansard Roof, Current Condition is Good.

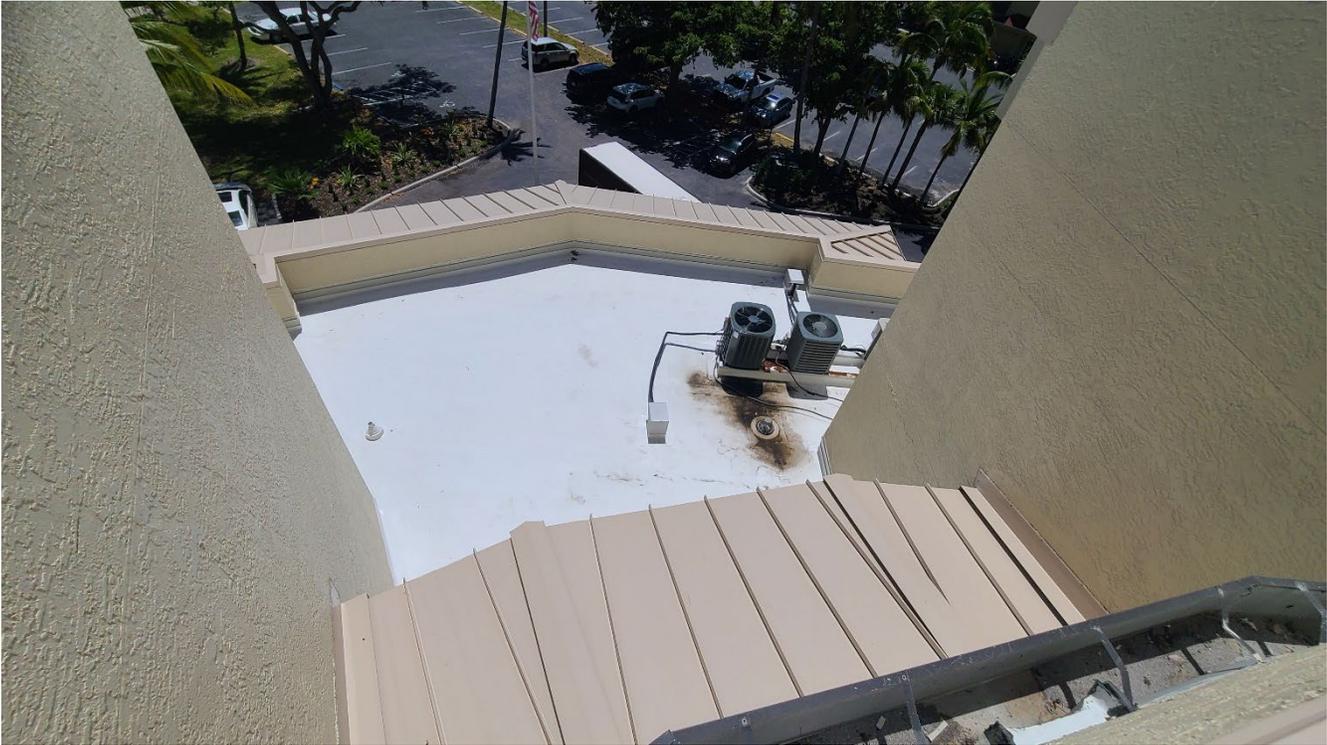
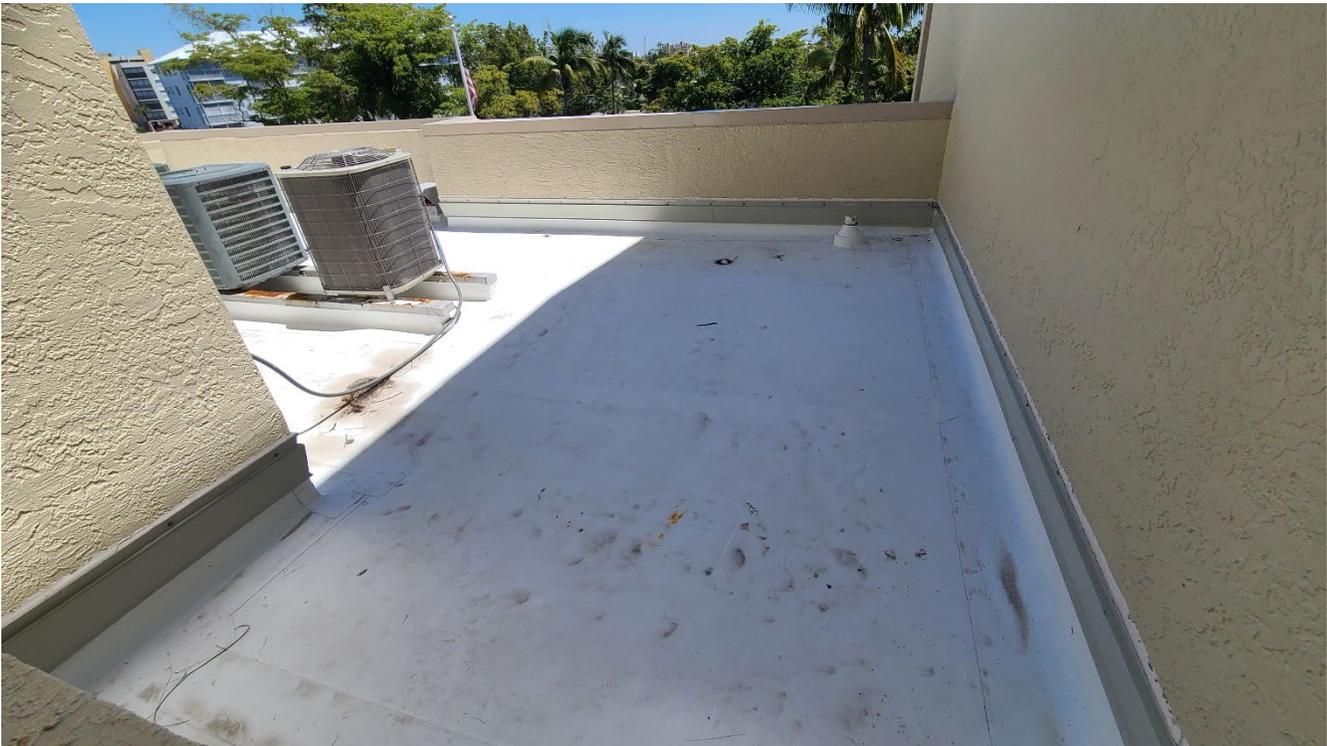
Photograph 8: Retailed Area / Central Flat Roof, Current Condition is Good.

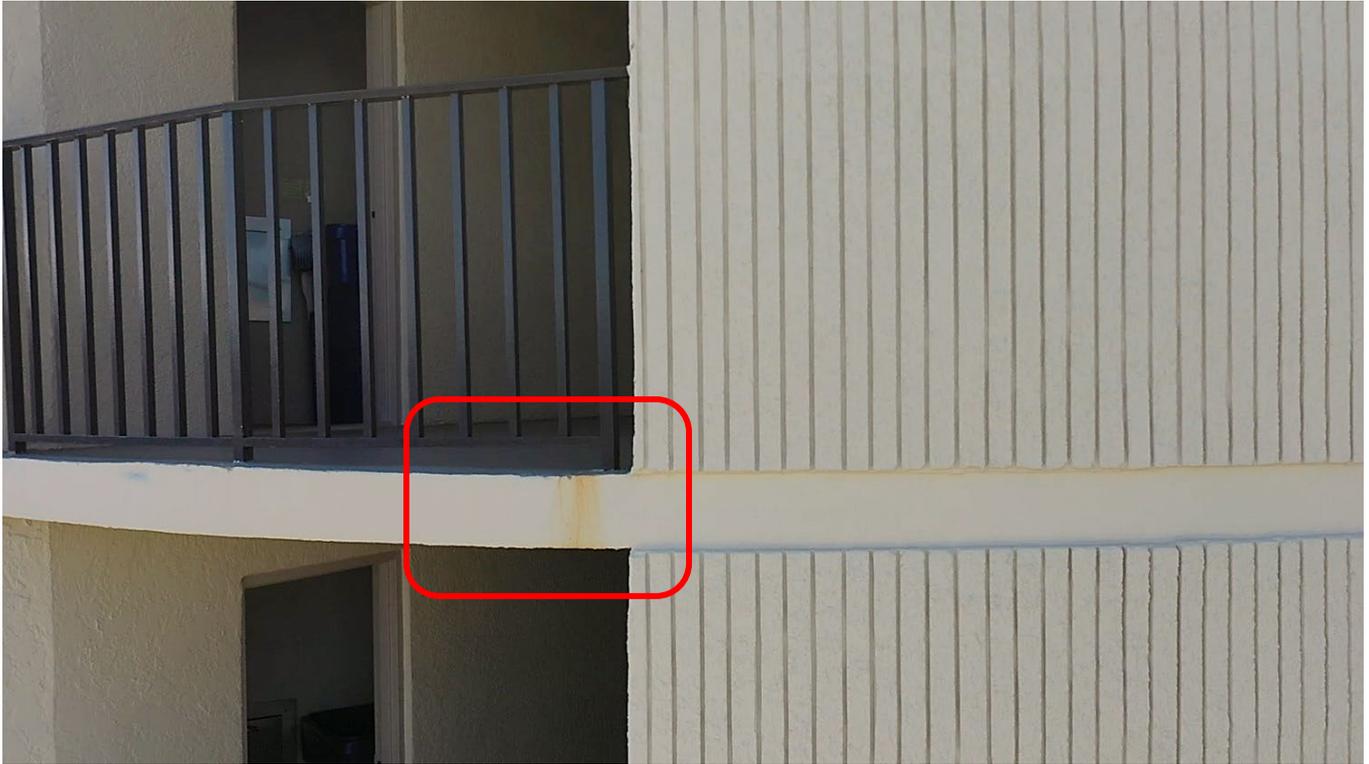
Photograph 9: North Stairwell at 5th Level – Example of Stain Mark on Exterior Edge.

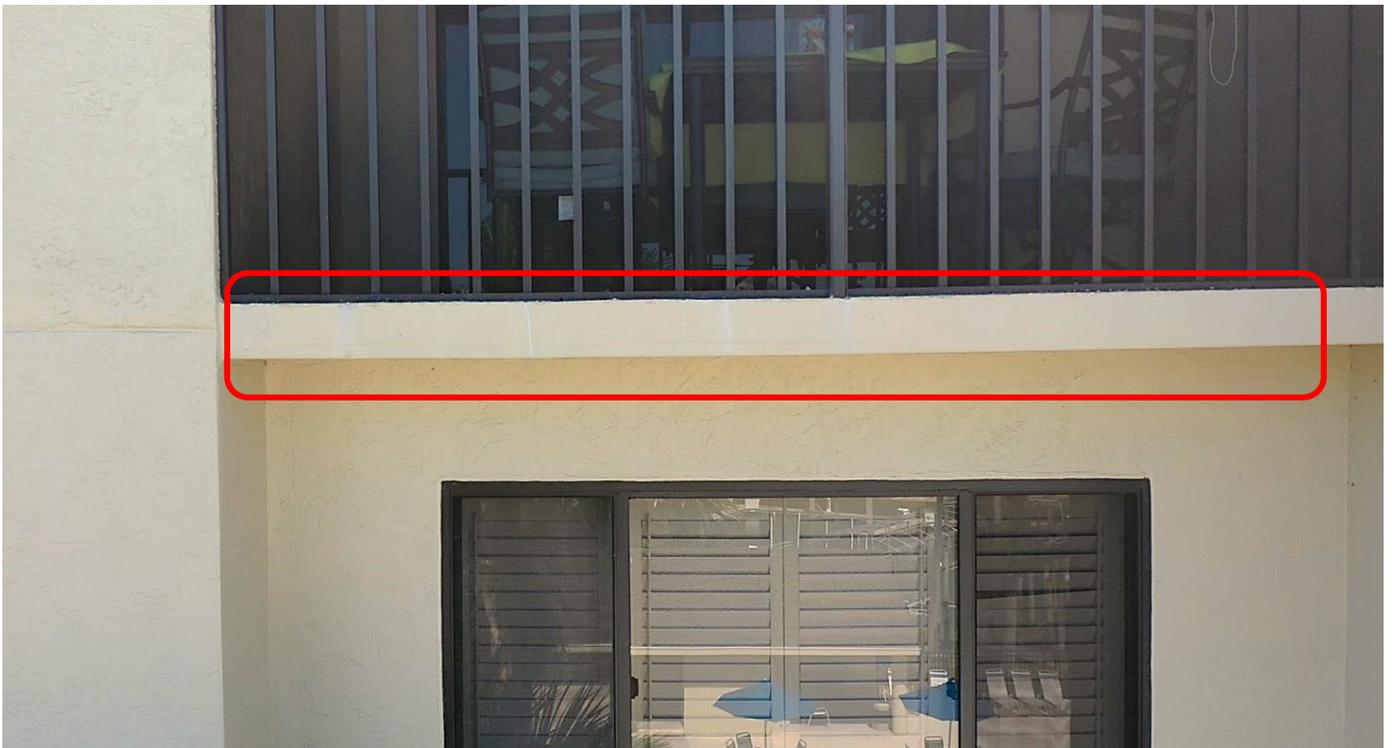
Photograph 10: North Bldg., Northeast Patio at 5th Level – Example of efflorescence on Exterior Edge.

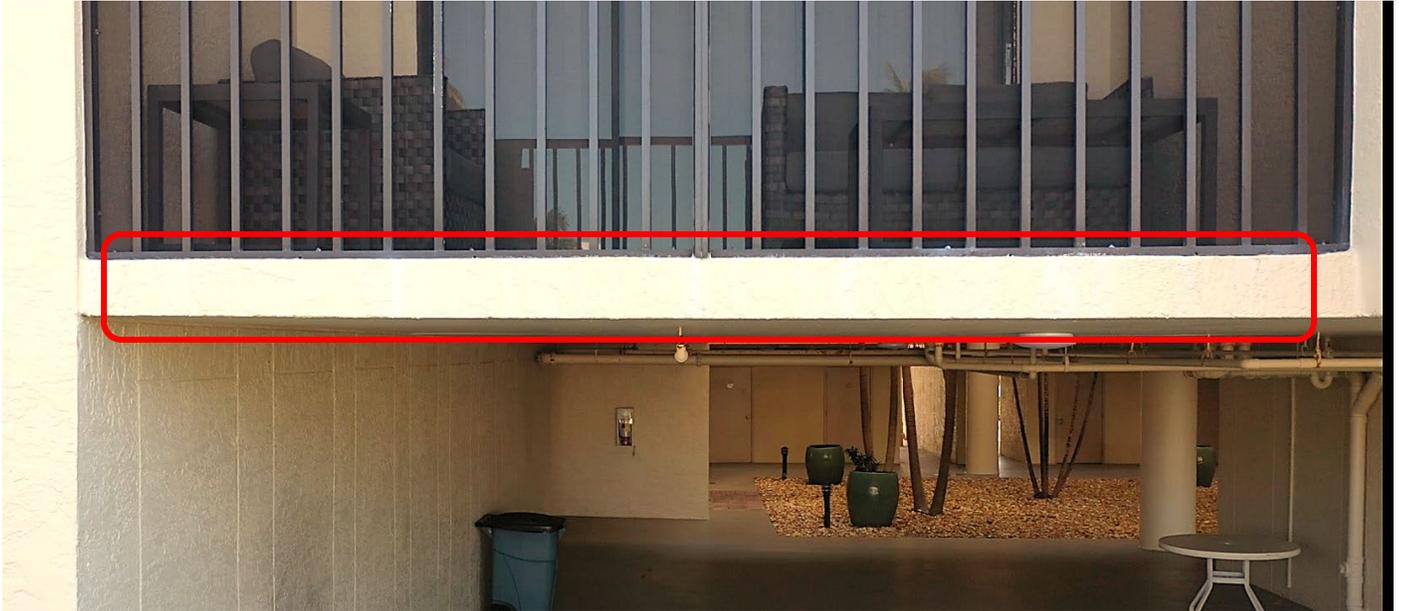
Photograph 11: North Bldg., 2nd Patio Stack from Northwest at 2nd Level – Example of efflorescence on Exterior Edge.

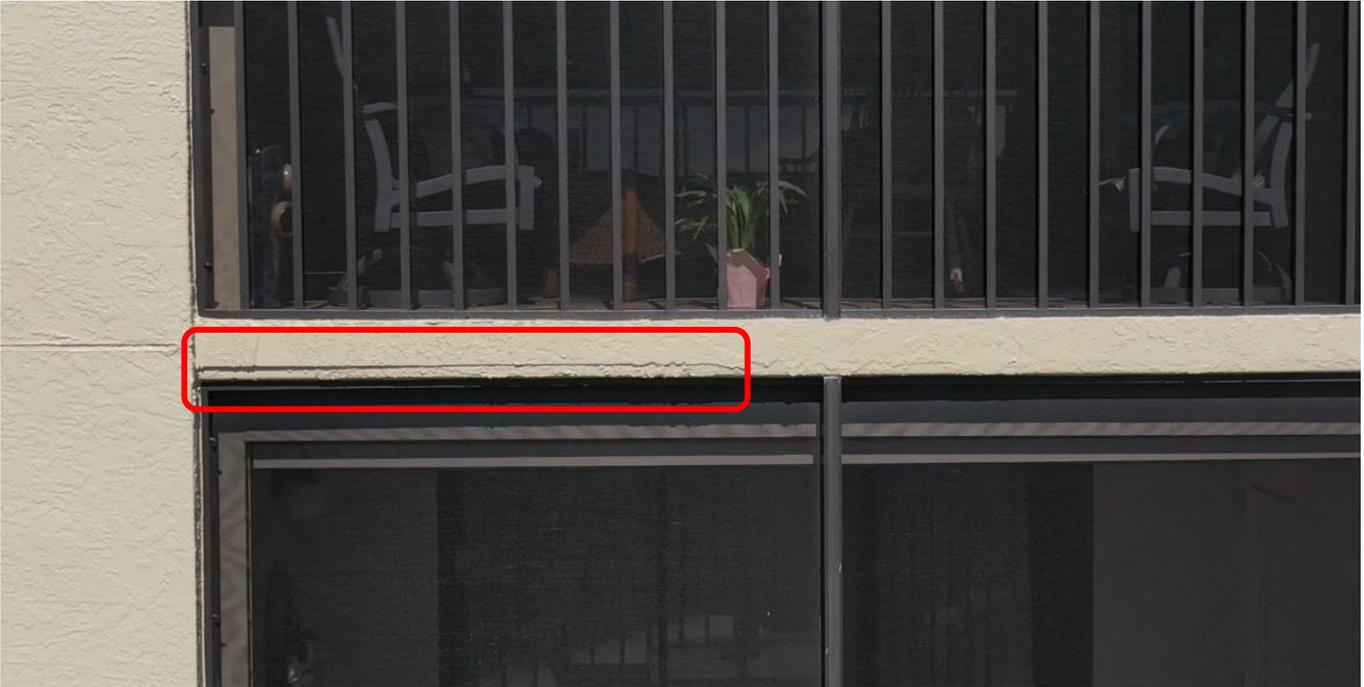
<p>g. Cracks: Note location in significant structural members: Cracked exterior balcony/patio and windowsills as the following:</p> <p>a. Cracked exterior patio edge at North Bldg. – Northeast patio at 5th level.</p>
<p>h. General extent of deterioration: Cracking or spalling of concrete or masonry, oxidation (corrosion) of metals; rot or borer attack in wood: Not Applicable.</p>
<p>i. Previous patching or repairs (Provide description and identify location): Not Applicable.</p>
<p>j. Nature of present loading: (indicate residential, commercial, storage, other): Residential.</p>
<p>k. Signs of overloading? Yes <input type="checkbox"/> No <input checked="" type="checkbox"/></p> <p>1. If yes, describe:</p>
<p>6. Masonry Bearing Wall: (indicate good, fair, poor on appropriate lines)</p>
<p>a. Concrete masonry units: Good.</p>
<p>b. Clay tile or terra cotta units: Not Applicable.</p>
<p>c. Reinforced concrete tie columns: Good.</p>

Photograph 15: North Bldg., Northeast Patio at 5th Level – Cracked Exterior Edge.

- Install a proper waterproofing membrane at all walkway decks.
- Install a proper waterproofing membrane at all patio decks.
- Where missed, install weep holes at the screen's bottom frame to permit draining of water sufficiently.
- Where missed, install weep holes and self-leveling sealant at the bottom of guardrail posts.
- Seal all wall penetration with fire-rated inside all the common area rooms.
- Clean and paint and/or replace the rusted fire pipes at the walkways.
- Remediate the cracked patios' exterior edge for North Bldg. – northeast patio at 5th level.

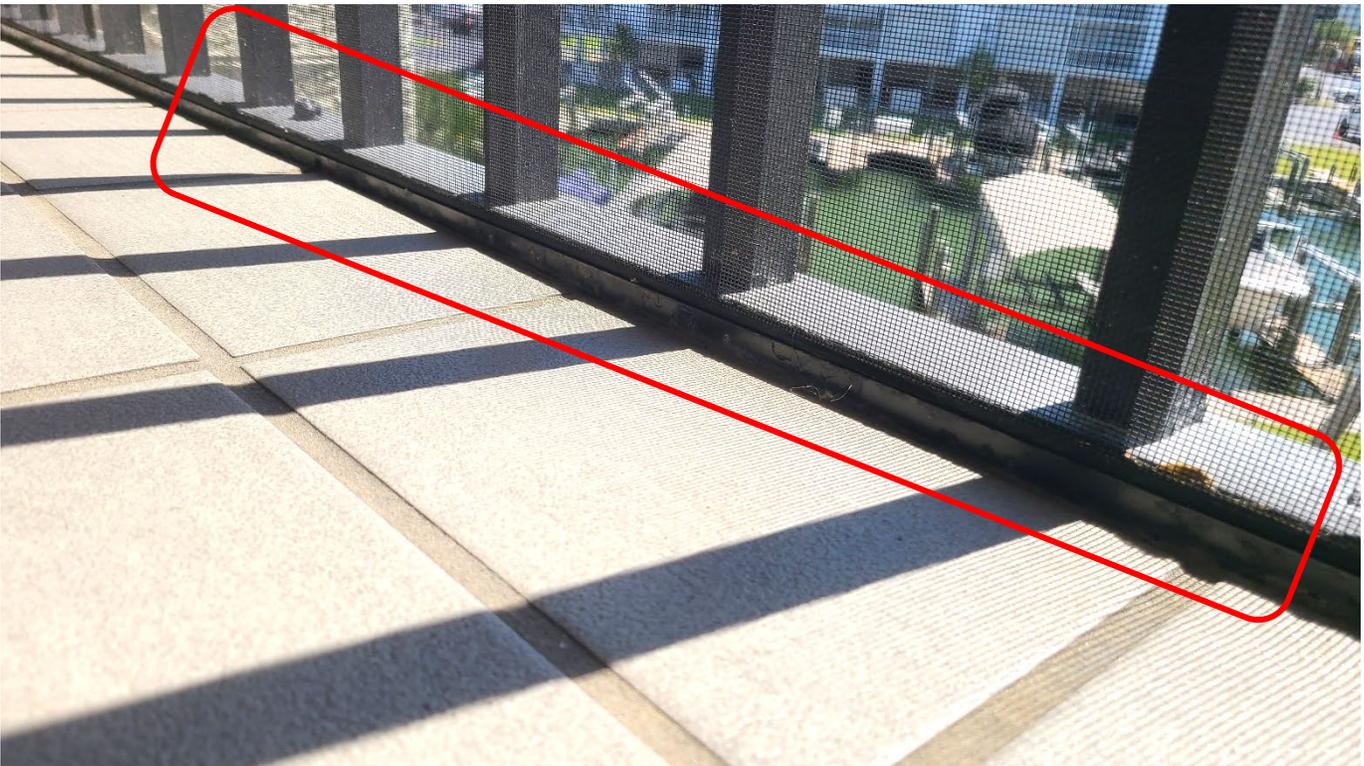
- 2. Balconies, indicate location, framing system, material, and condition:** Unit balconies/patios are extended elements of the reinforced concrete slab/floor system. All unit patios are enclosed with a screen-guardrail integrated system. Unit patios are located on the building's southeast and northwest elevations. The majority of patio decks are covered with tiles. However, no evidence of waterproofing was installed below the tile. During our inspection, we noticed that the screen's bottom frames are not equipped with weep holes. This may cause water to entrap on the exterior edge. We also detected that stain marks are visible on the majority of the exterior patio edges. This is likely due to the lack of deck membrane and weep holes at the screen's bottom frame. In addition, specific patios exhibit hollow sound tiles.

Photograph 16: Patio's Screen – Lack of Weep Holes at Bottom Frame

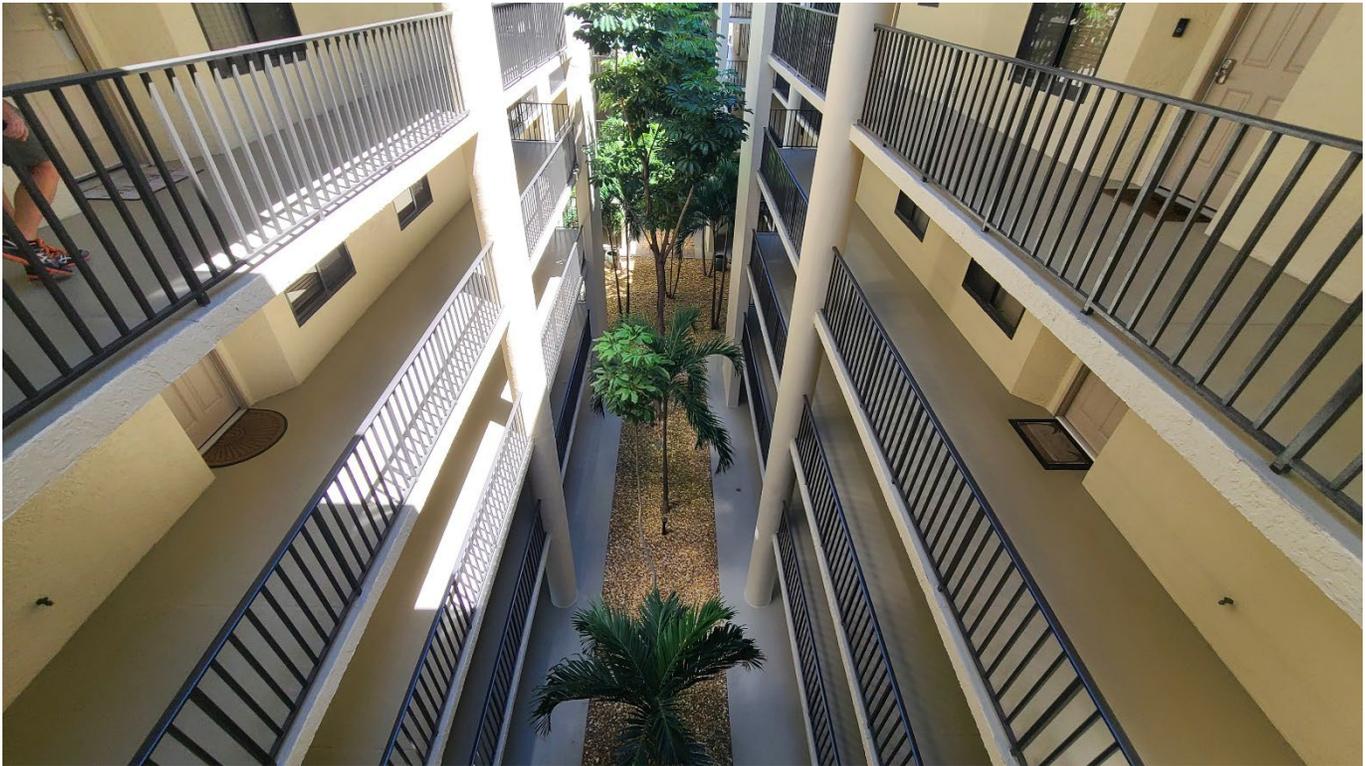
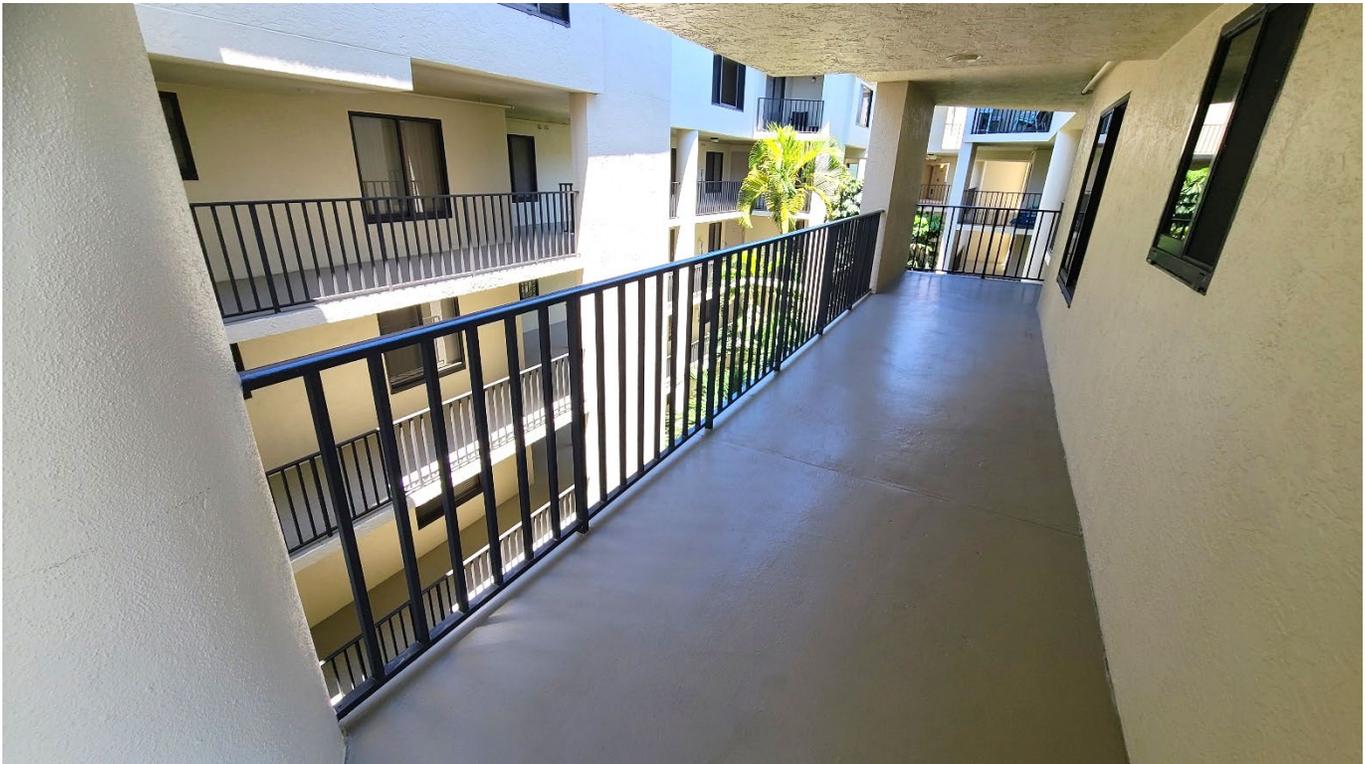
- 3. Walkways, indicate location, framing system, material, and condition:** The building walkways are extended elements of the reinforced concrete slab/floor system. All walkways appear coated with acrylic coating per the provided contract. However, no information was provided regarding any waterproofing

Photograph 17: Building Walkways, Current Condition.

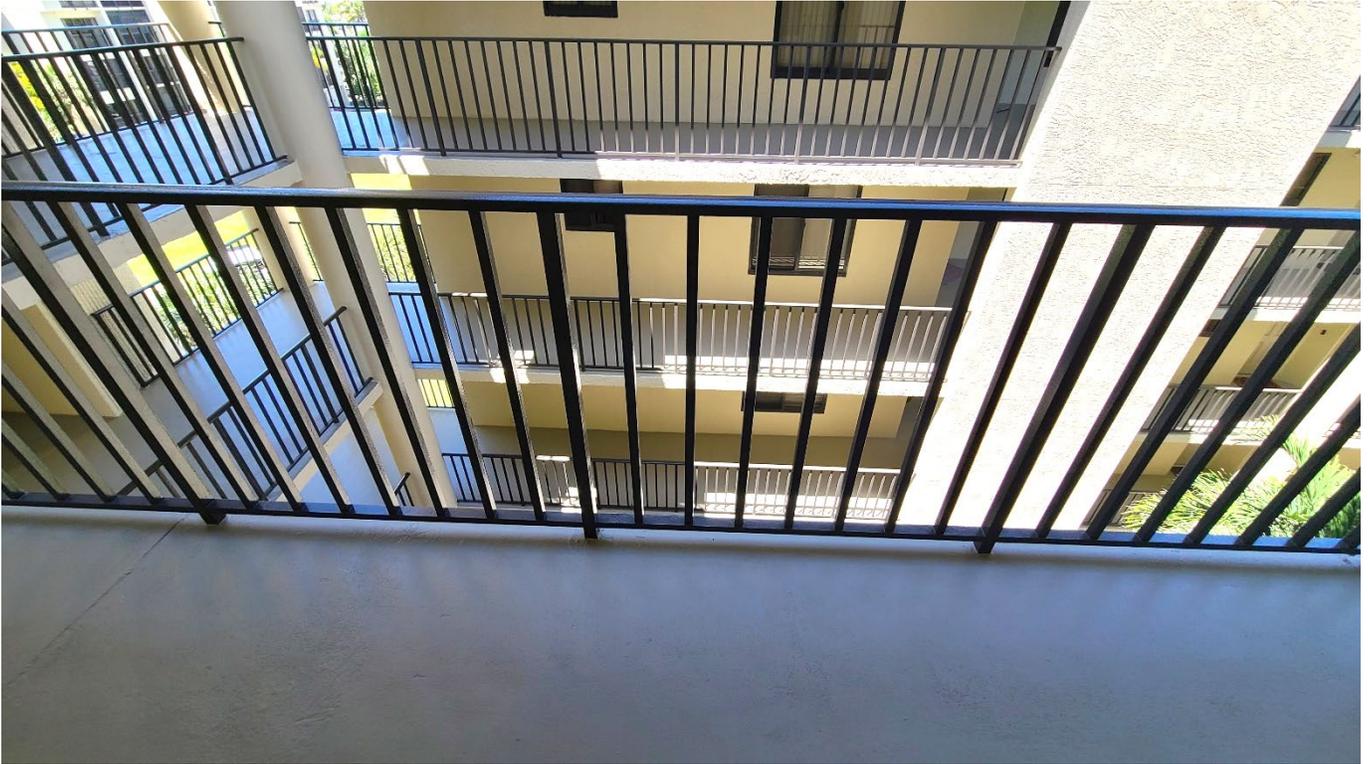
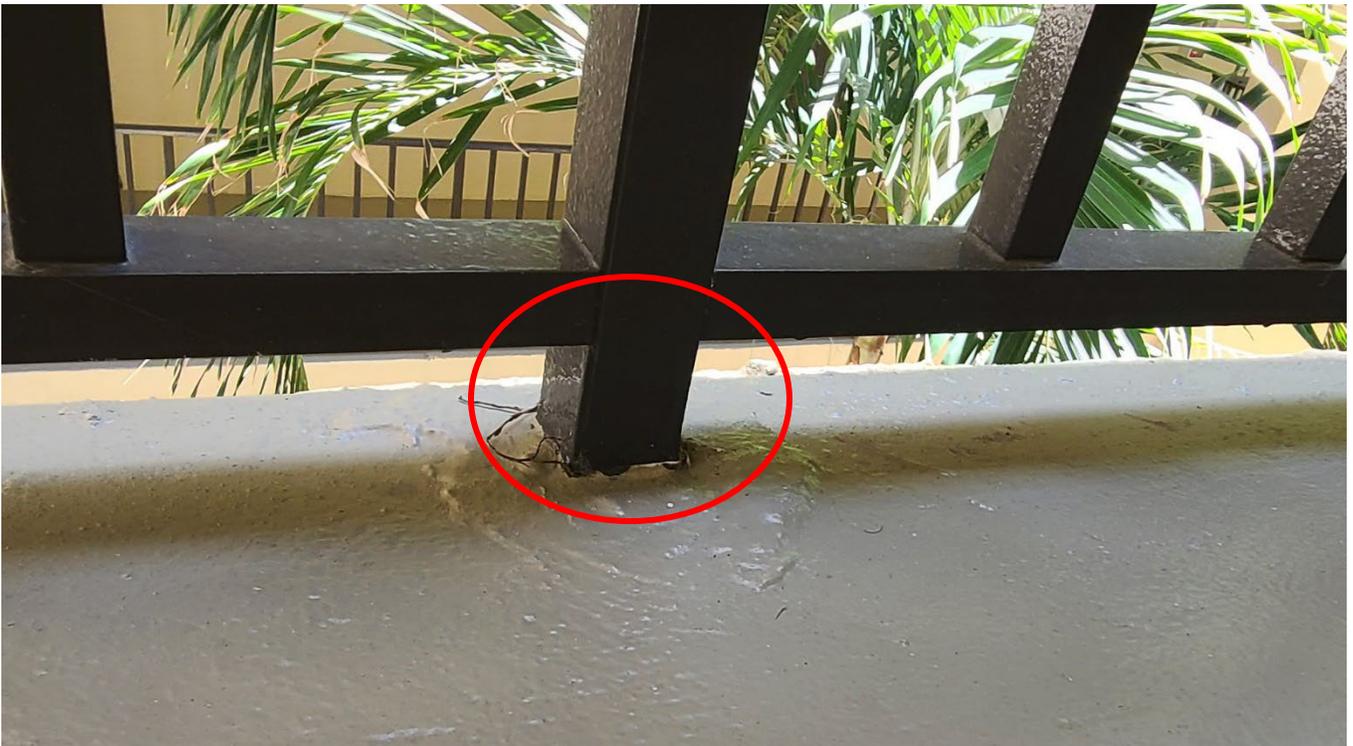
Photograph 19: Walkway Guards, Lack of Weep Holes at Bottom of Posts

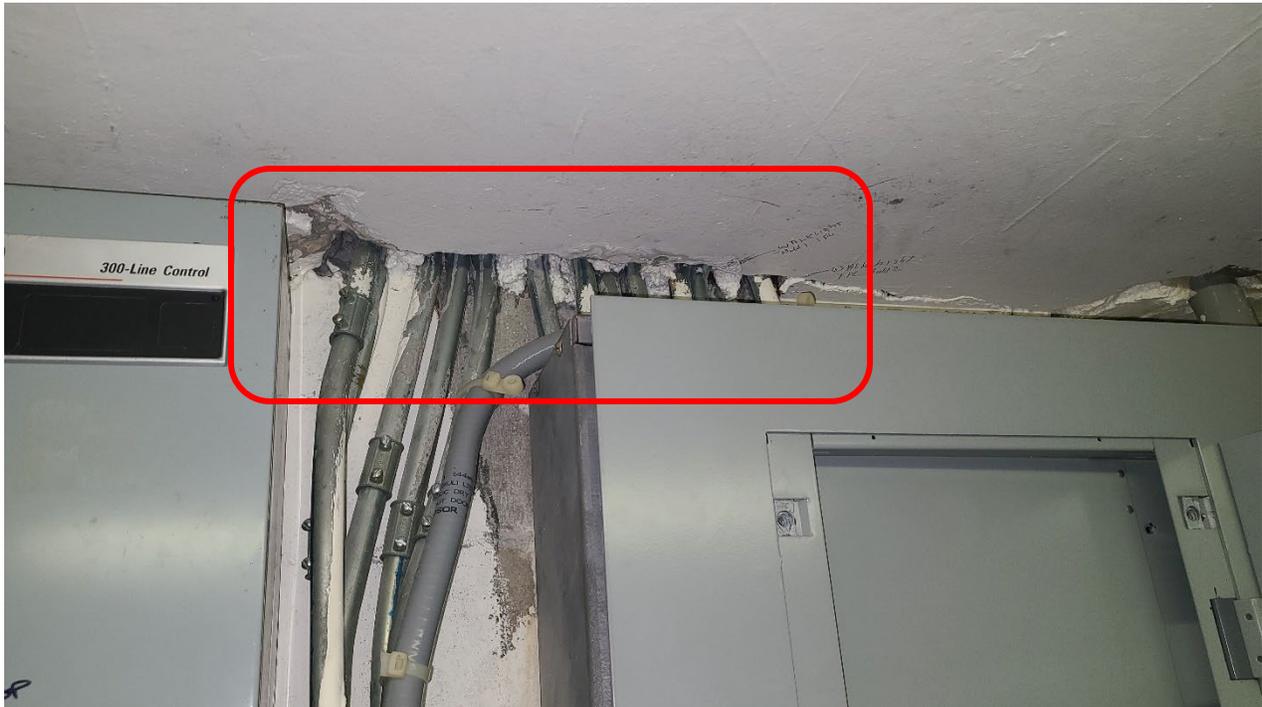
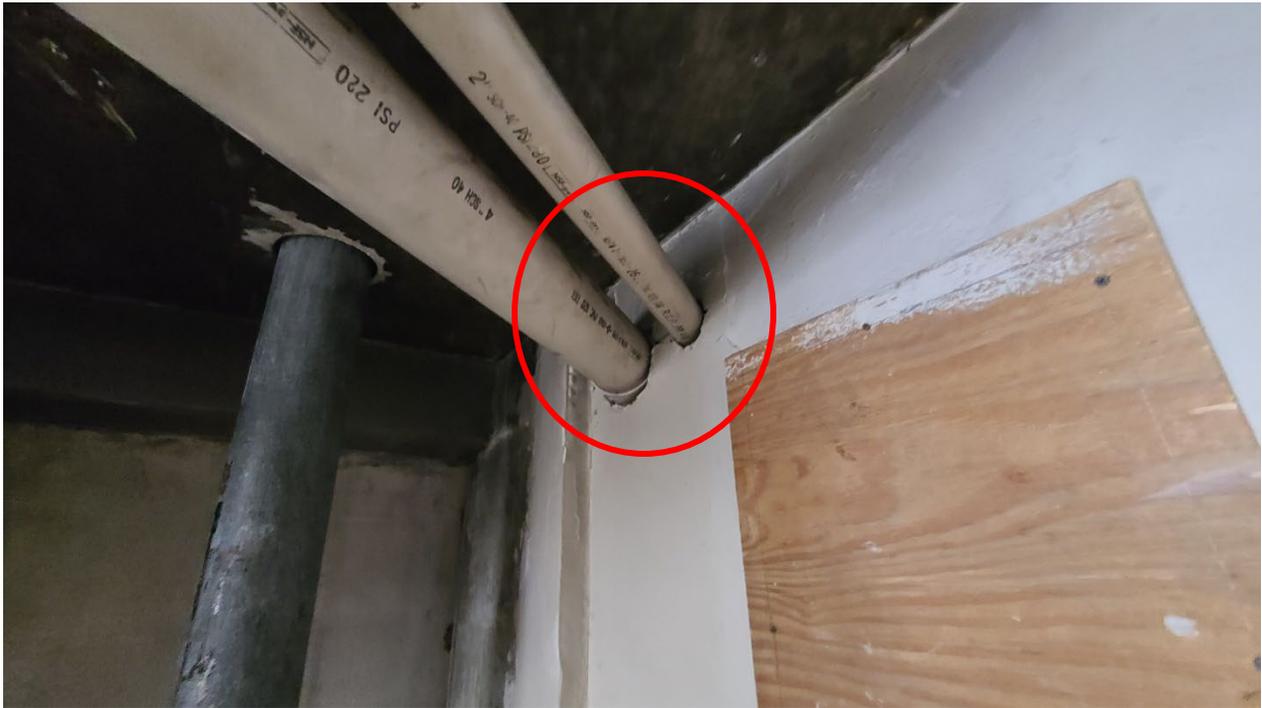
Photograph 37: Building Common Area – Example of Lack or Fire Rated Sealant at Wall Penetrations.

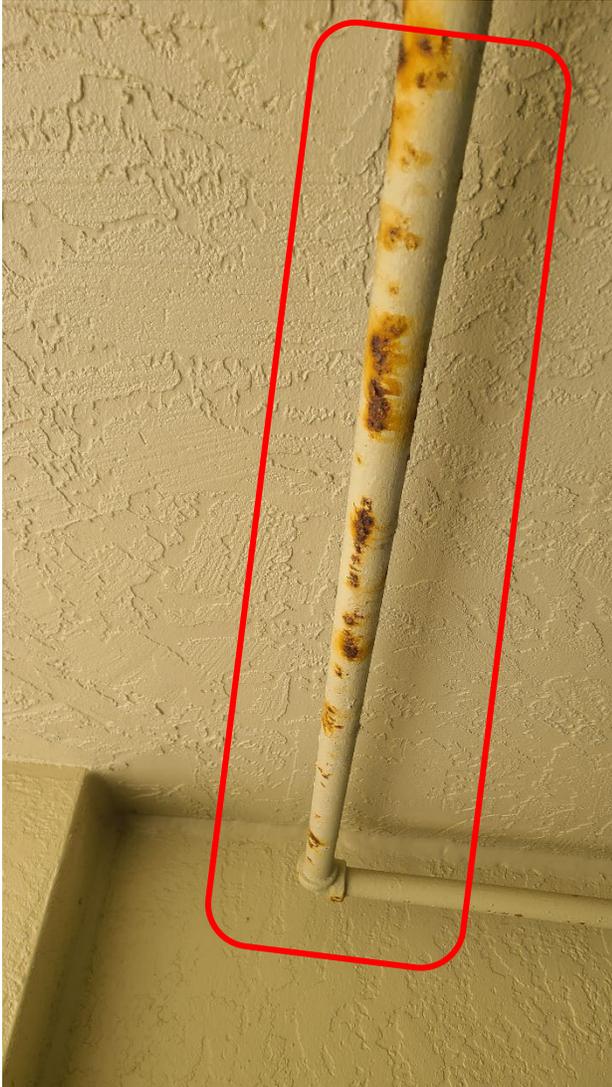
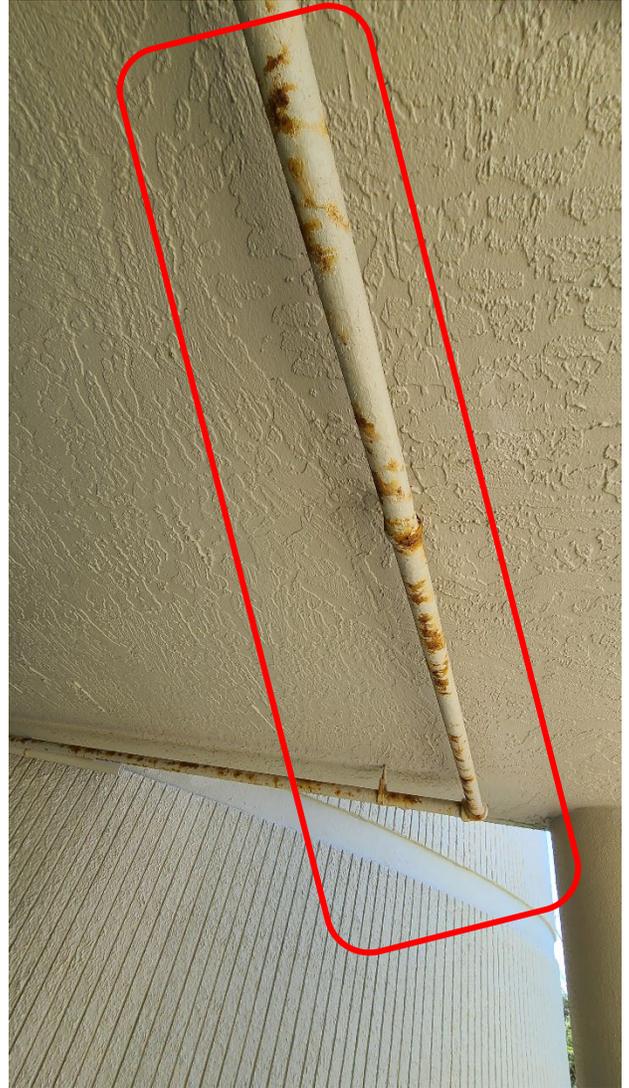
Photograph 38: Building Common Area, Example of Rusted Fire Pipes at the Walkways.
