May 15, 2024

Re: Santa Maria II Condominium Association, Inc.
Structural Integrity Reserve Study (SIRS)
7317 & 7327 Estero Blvd, Ft. Myers Beach, FL 33931
UES Project No: 6011.2400060.0000

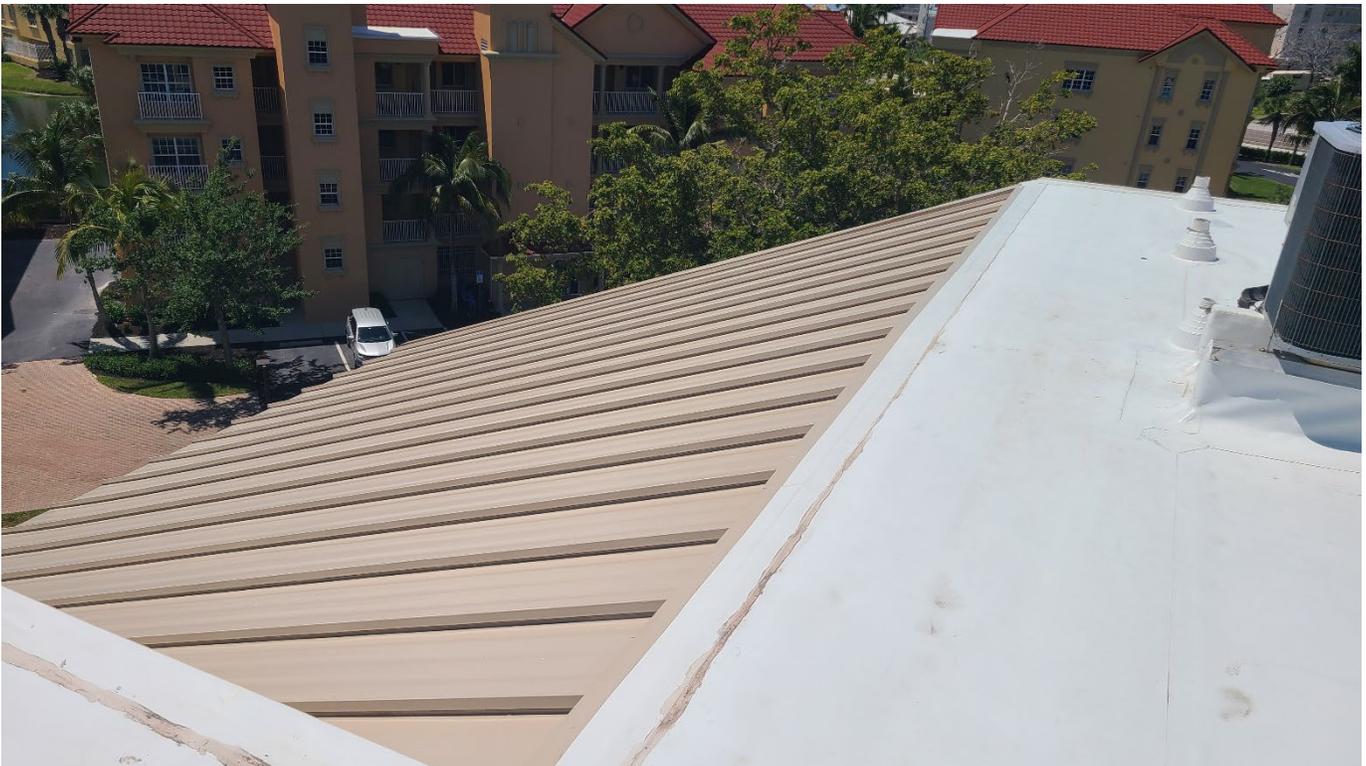
Photograph 7: Metal Mansard Roof, Current Condition is Good.

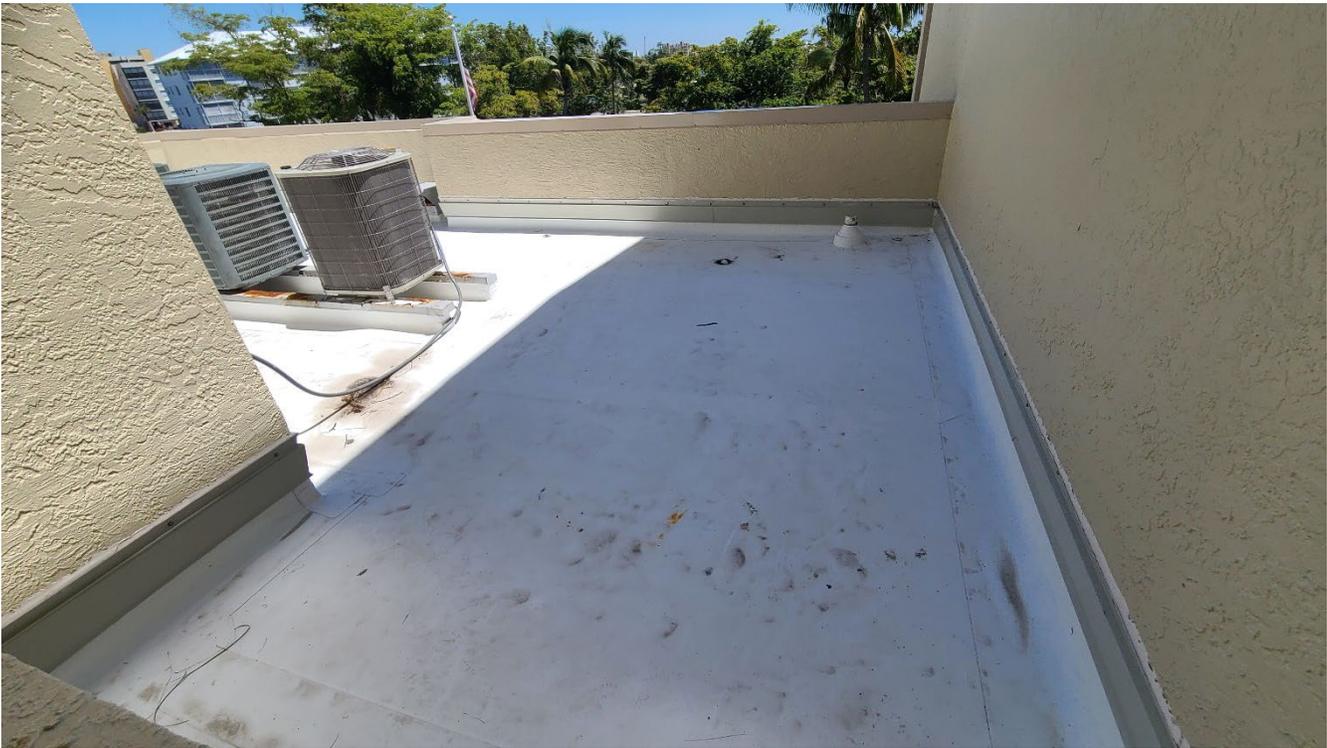
Photograph 8: Retailed Area / Central Flat Roof, Current Condition is Good.

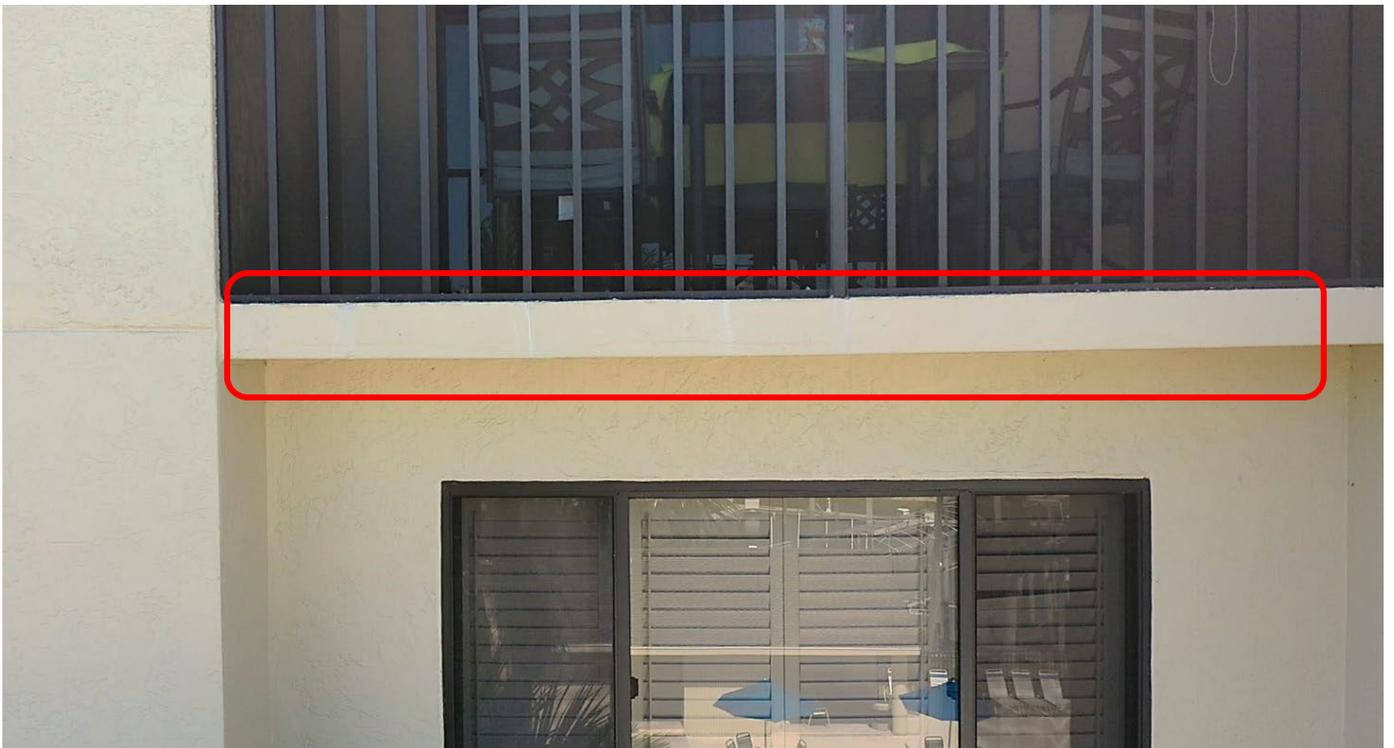
Photograph 10: North Bldg., Northeast Patio at 5th Level – Example of efflorescence on Exterior Edge.

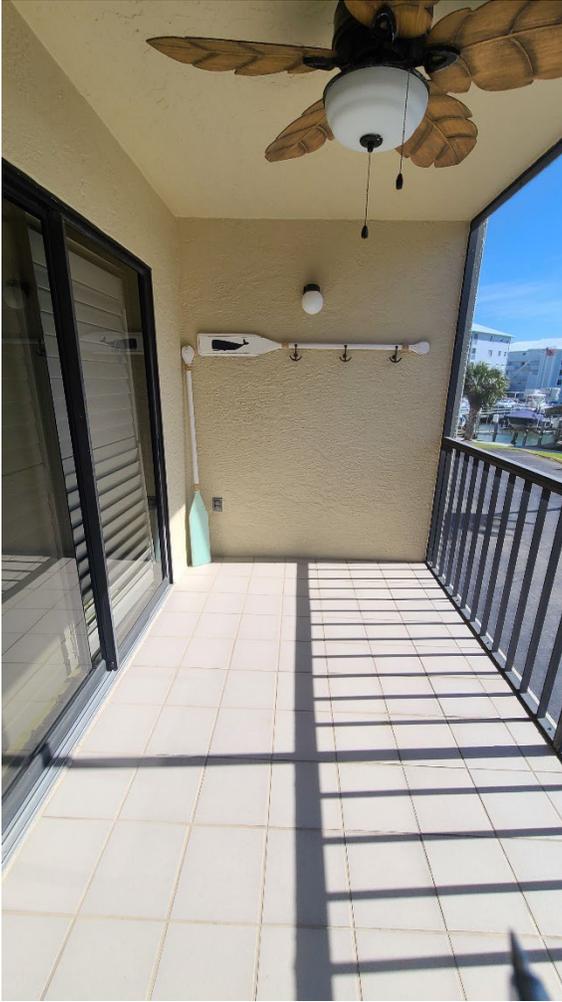
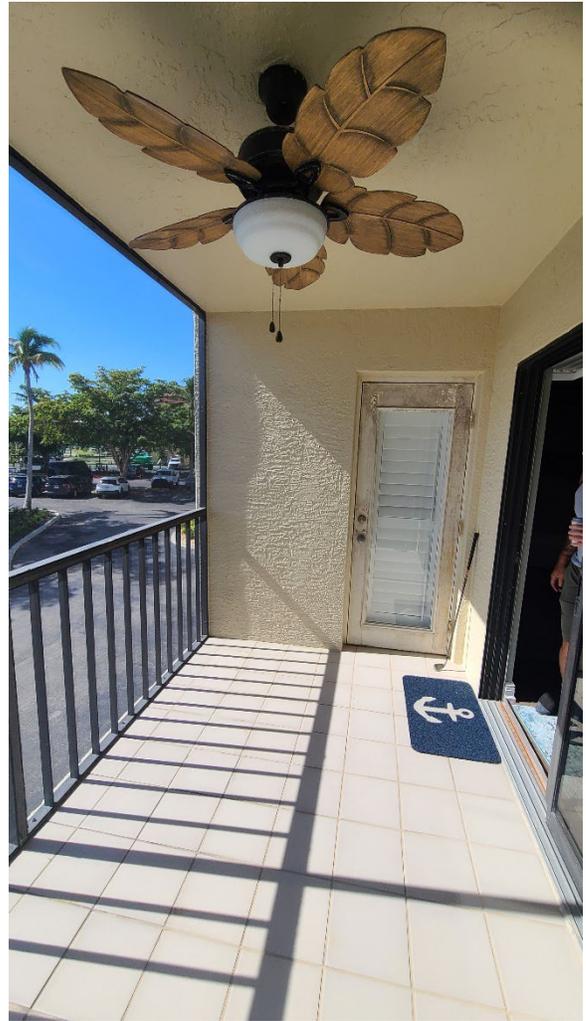
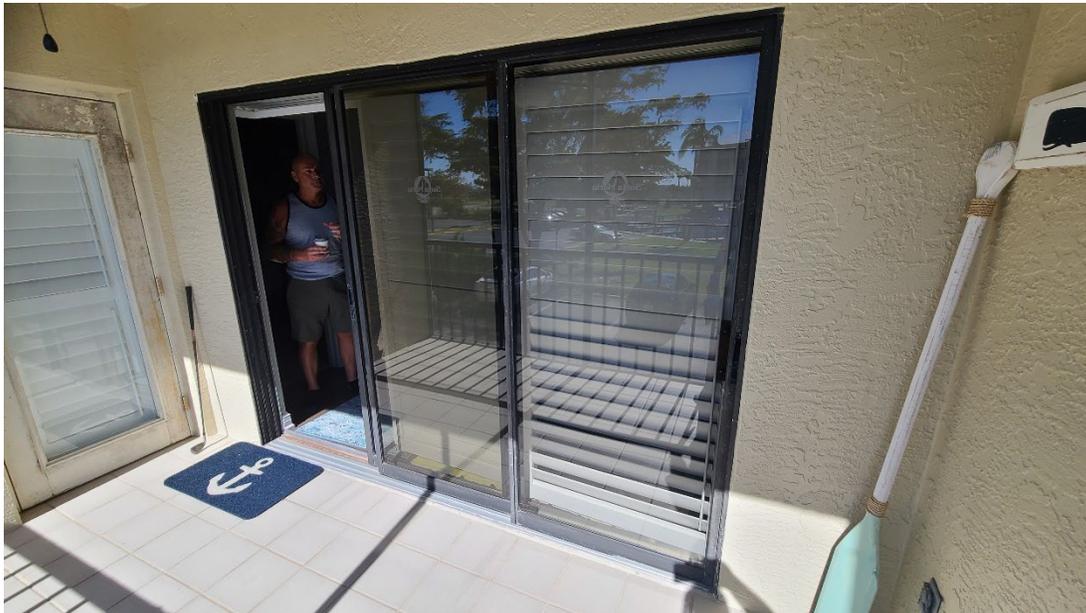
Photograph 12: Unit #107 Patio, Current Condition.

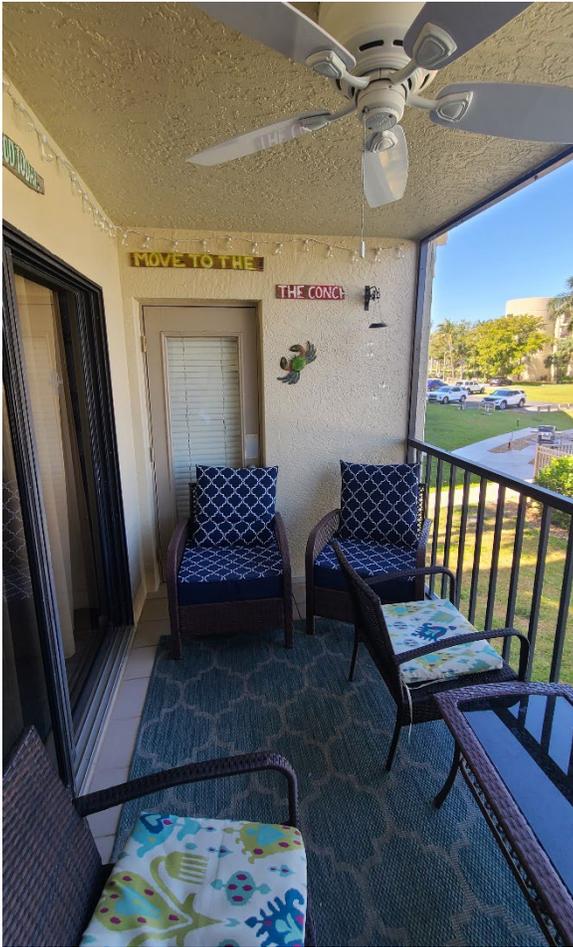
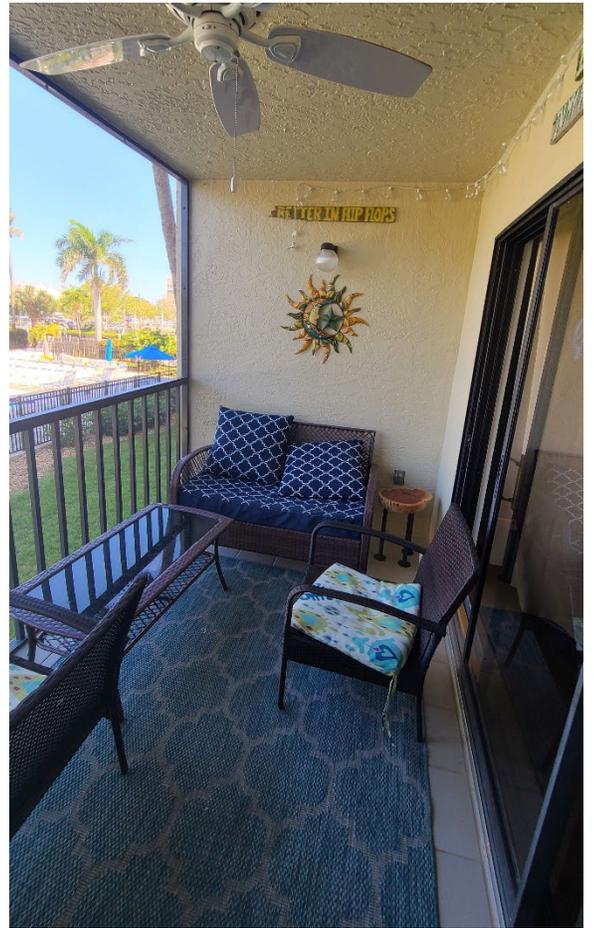
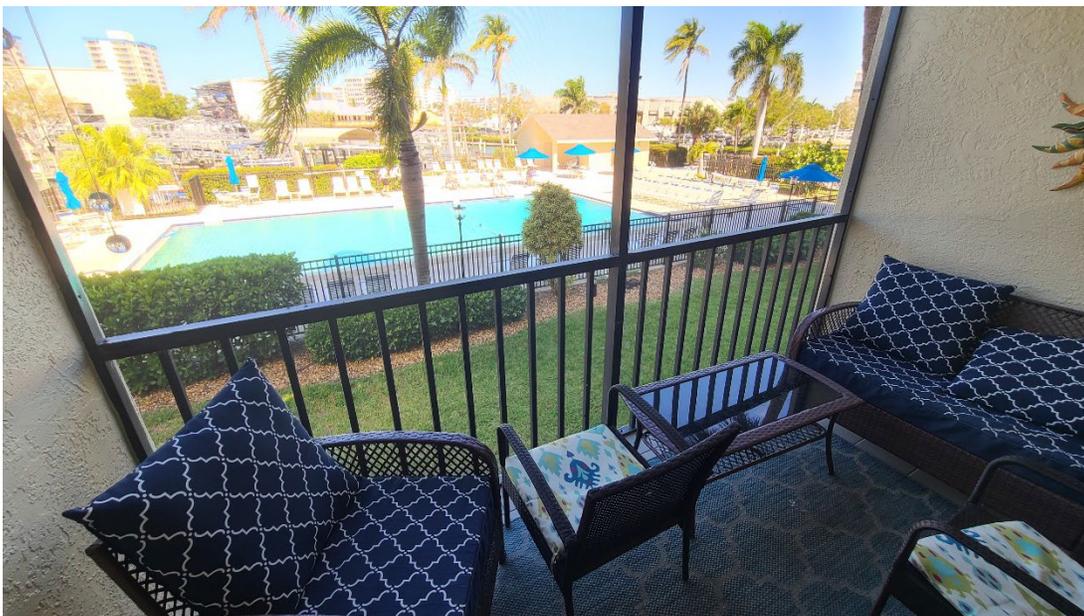
Photograph 13: Unit #106 Patio, Current Condition

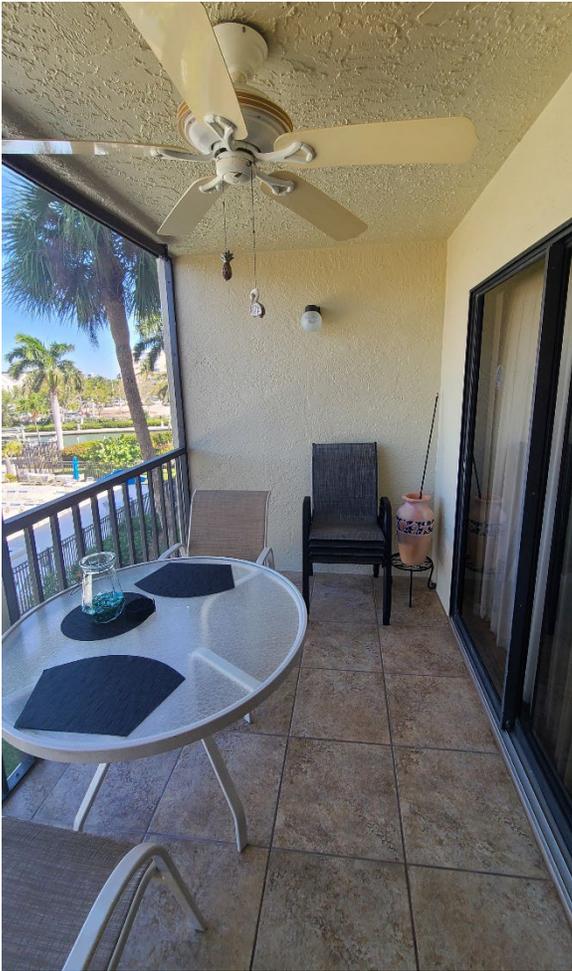
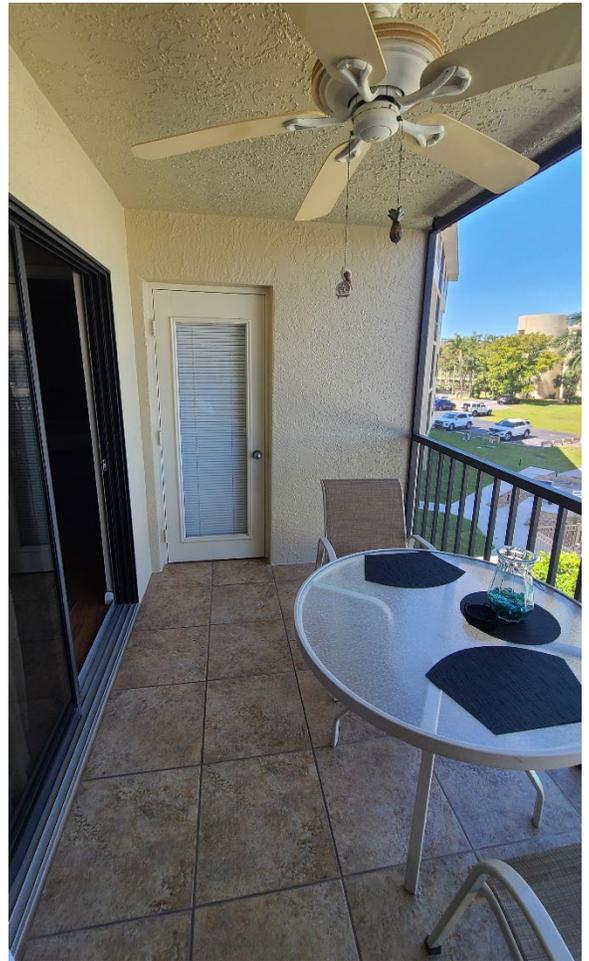
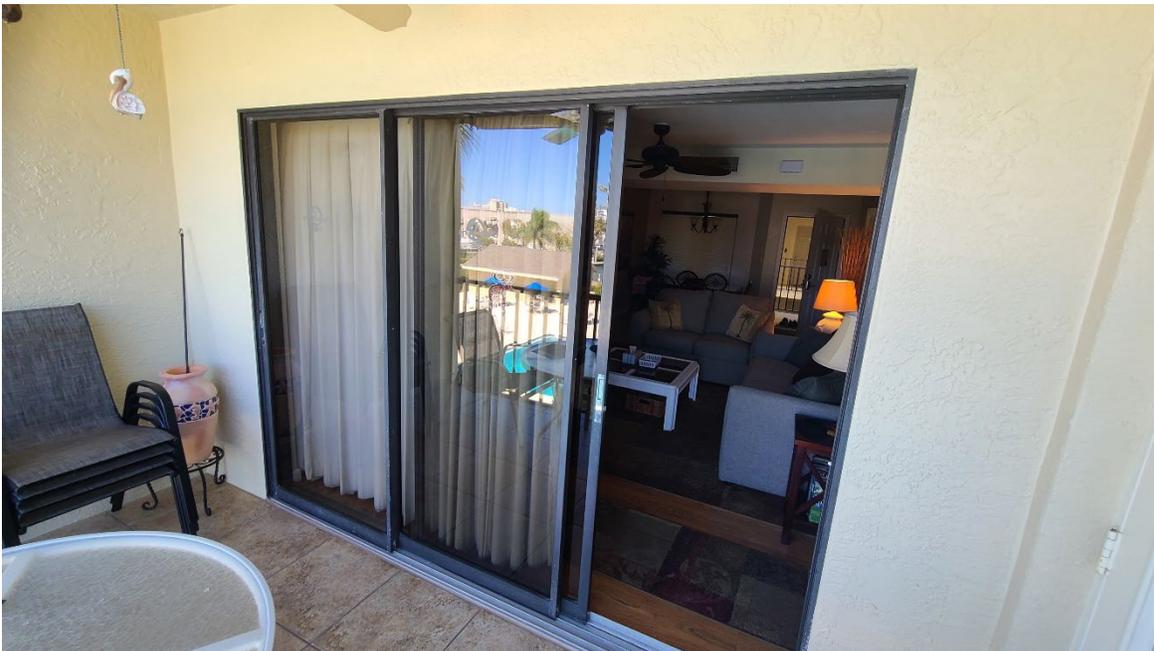
Photograph 14: Unit #206 Patio, Current Condition.

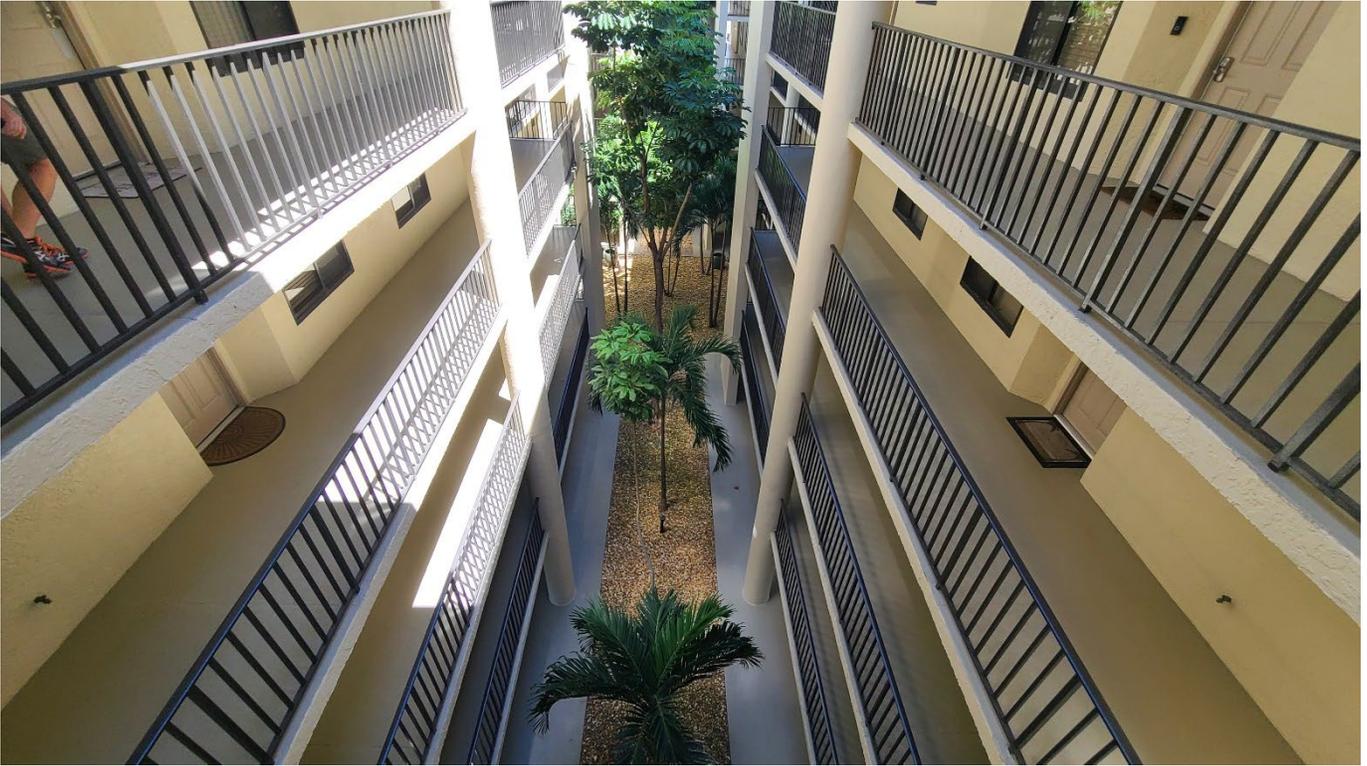
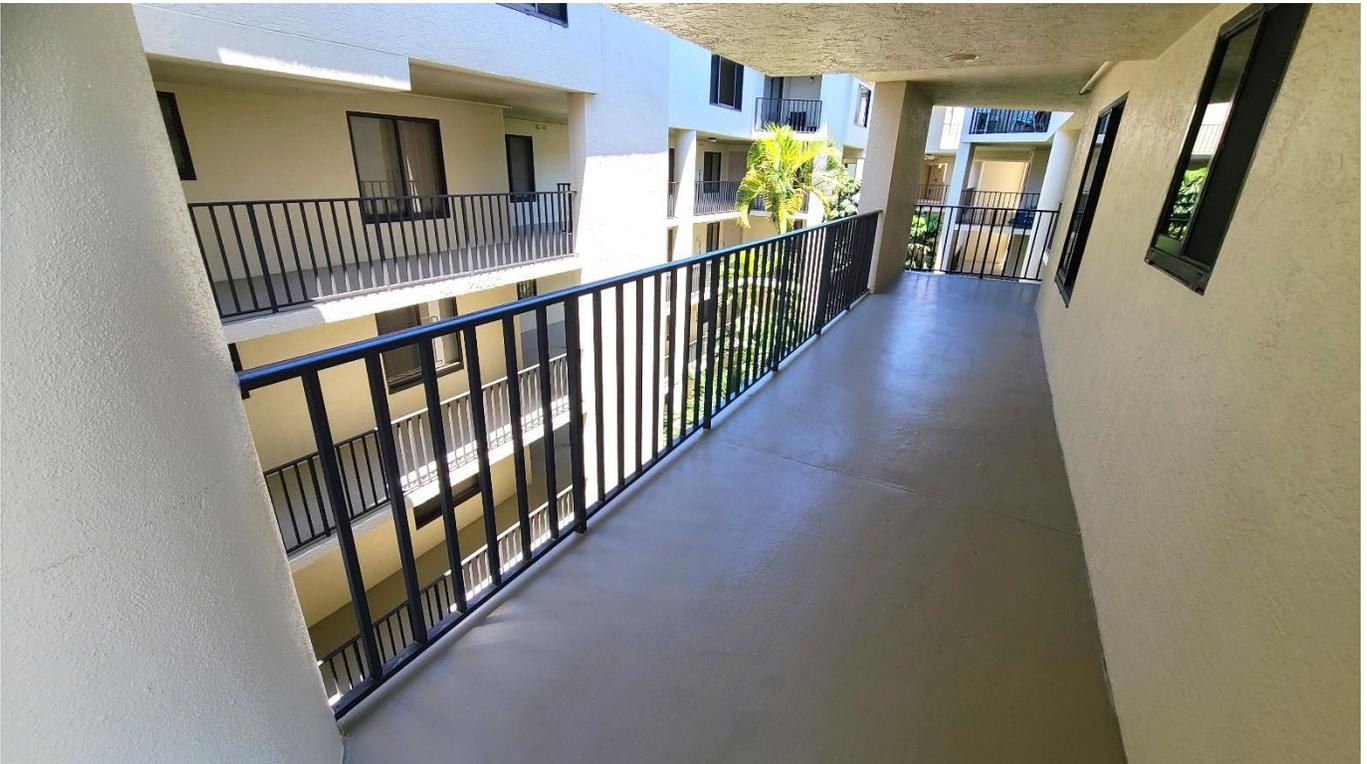
Photograph 17: Building Walkways, Current Condition.

- Install a proper waterproofing membrane at all walkway decks.
- Install a proper waterproofing membrane at all patio decks.
- Where missed, install weep holes at the screen's bottom frame to permit draining of water sufficiently.
- Where missed, install weep holes and self-leveling sealant at the bottom of guardrail posts.
- Seal all wall penetration with fire-rated inside all the common area rooms.
- Clean and paint and/or replace the rusted fire pipes at the walkways.
- Remediate the cracked patios' exterior edge for North Bldg. – northeast patio at 5th level.

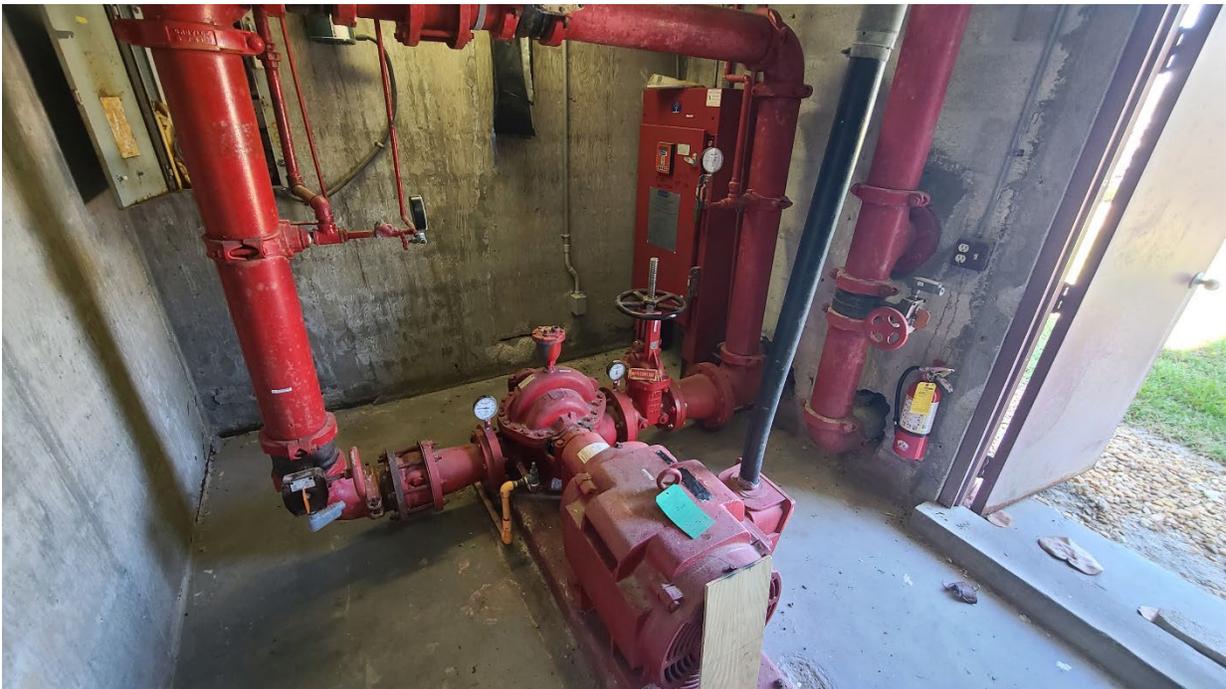
Photograph 34: Building Common Area, Fire Pump Ground Level, Current Condition.

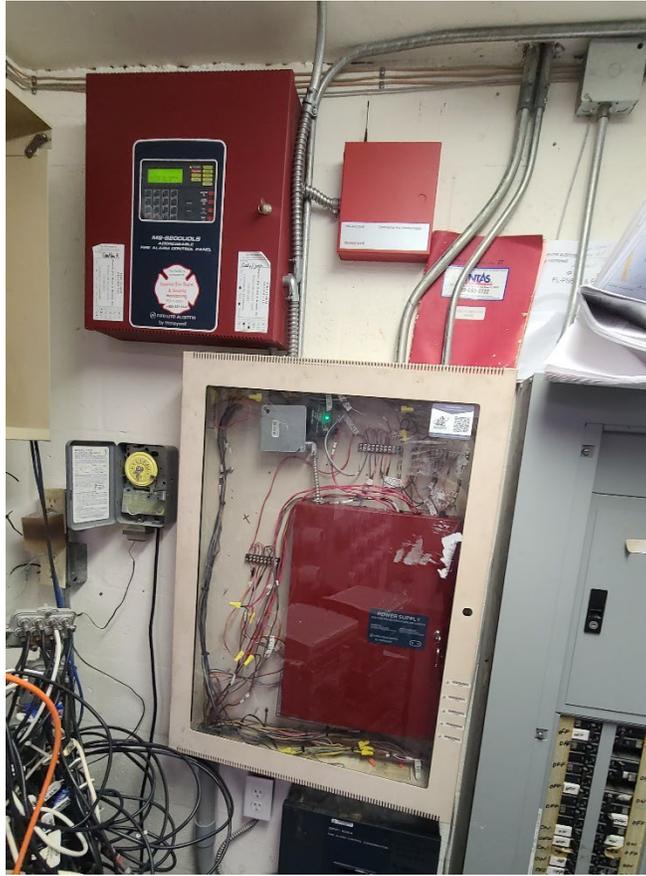
Photograph 35: Building Common Area, Fire Alarm Equipment Inside the Power Room, Current Condition.

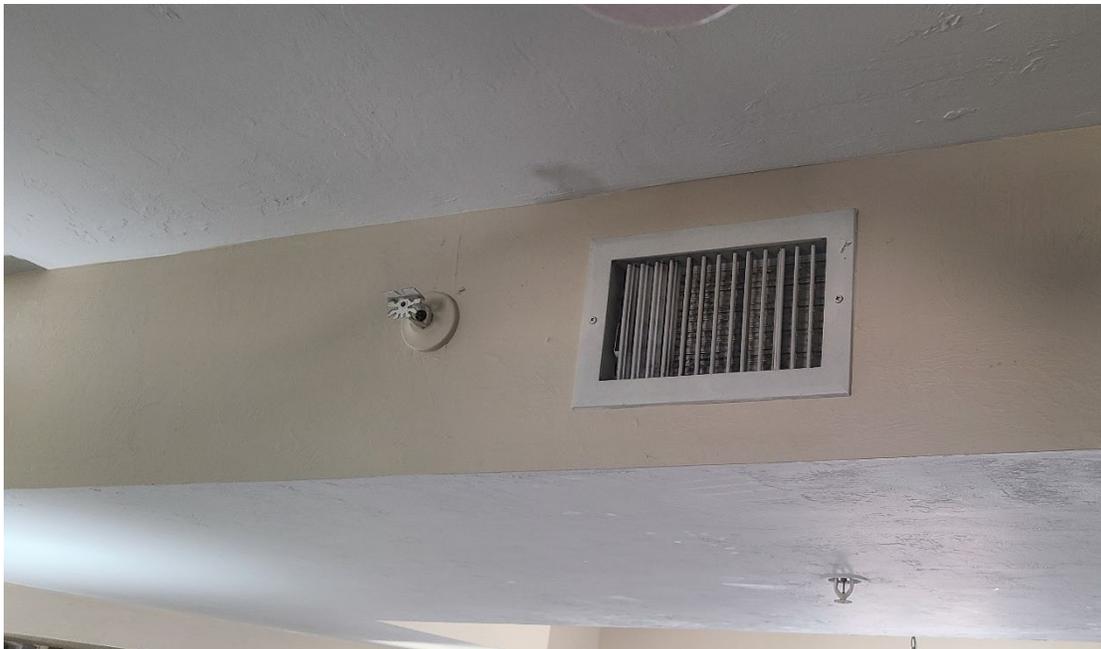
Photograph 36: Fire Sprinkler inside the Unit.

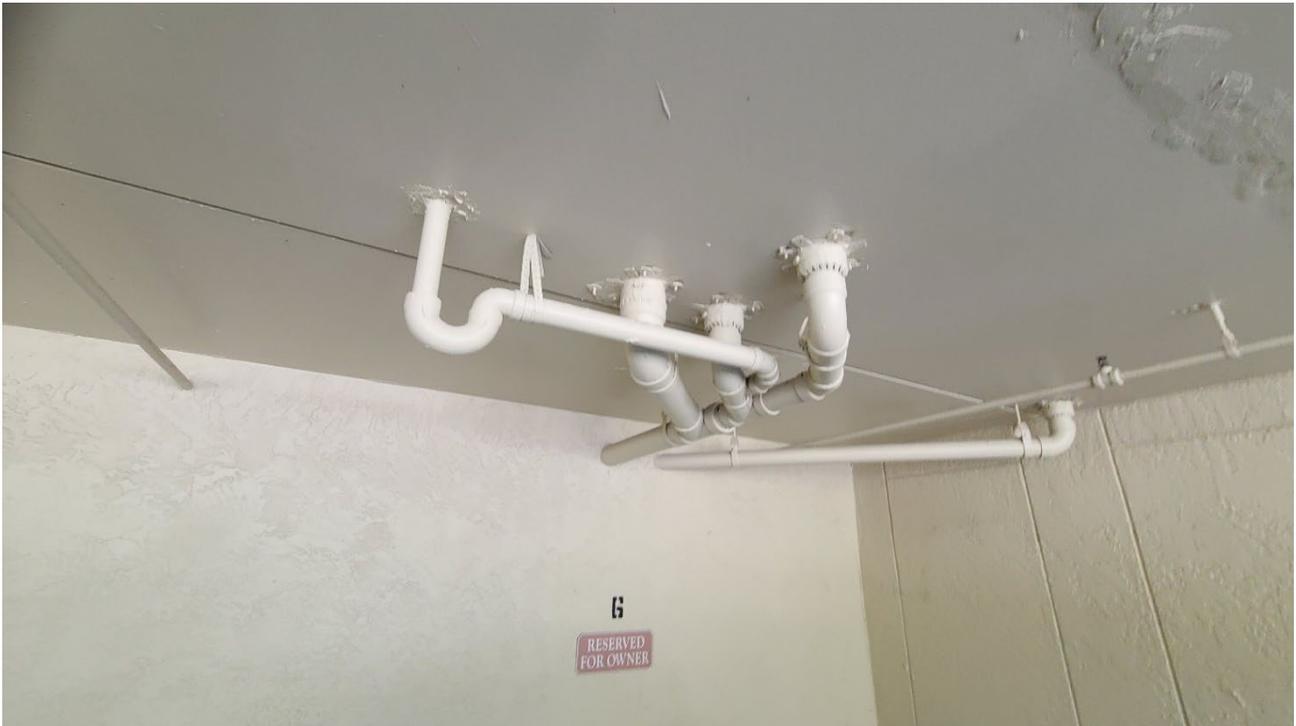
Photograph 39: Building Common Area, Plumbing Stack Pipes (PVC), Current Condition.
