Uniform Mitigation Verification

7317-7327 Estero Blvd

Fort Myers Beach

Prepared for
Santa Maria II Condo Association

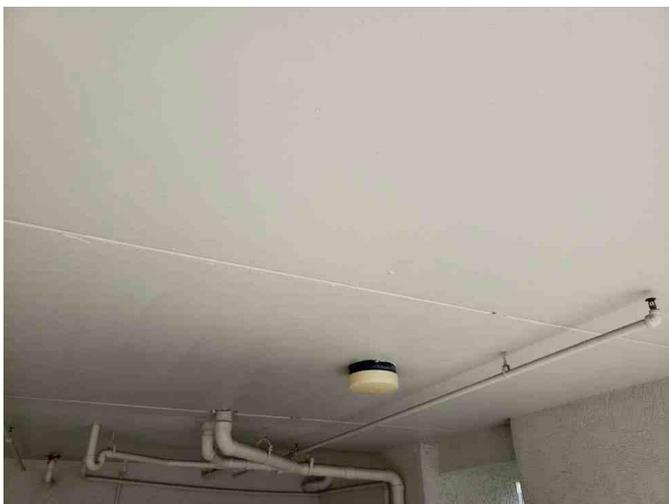
- D. Reinforced Concrete Roof Deck.
- E. Other: _____
- F. Unknown or unidentified.
- G. No attic access.

Reinforced Concrete

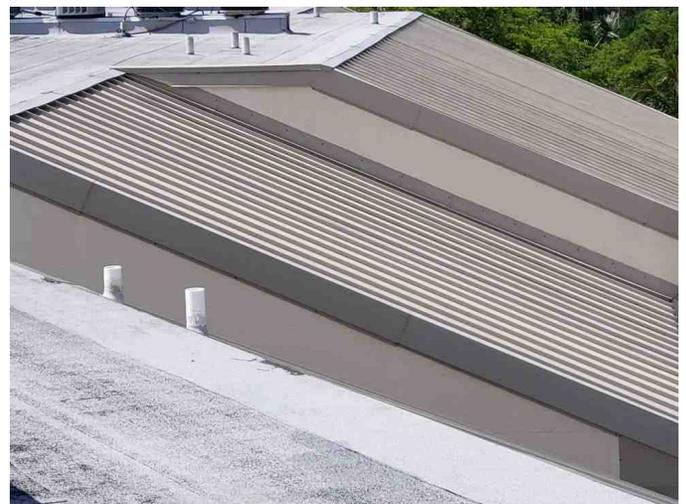
Metal Roof

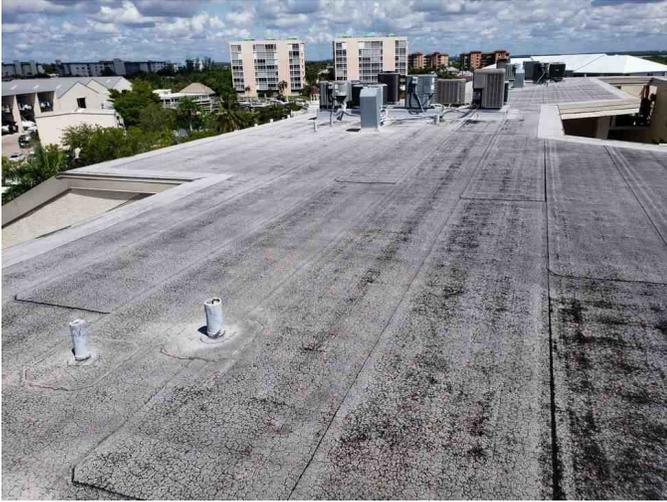
- A. Hip Roof Hip roof with no other roof shapes greater than 10% of the total roof system perimeter.
Total length of non-hip features: _____ feet; Total roof system perimeter: _____ feet
- B. Flat Roof Roof on a building with 5 or more units where at least 90% of the main roof area has a roof slope of less than 2:12. Roof area with slope less than 2:12 31,250 sq ft; Total roof area 31,250 sq ft
- C. Other Roof Any roof that does not qualify as either (A) or (B) above.

Built Up Roof

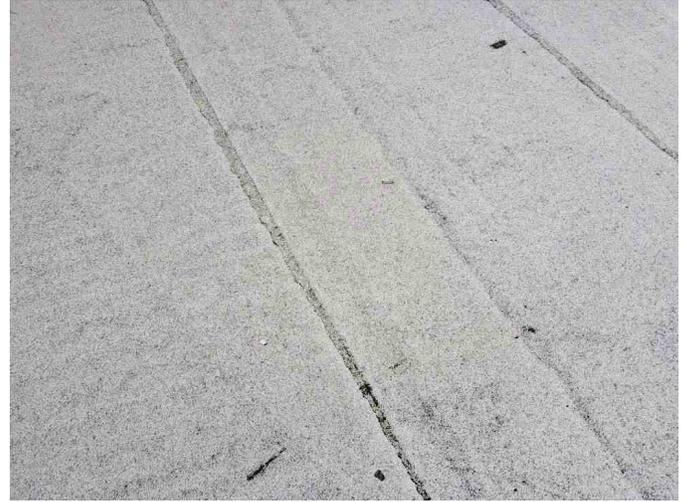
Built Up Roof

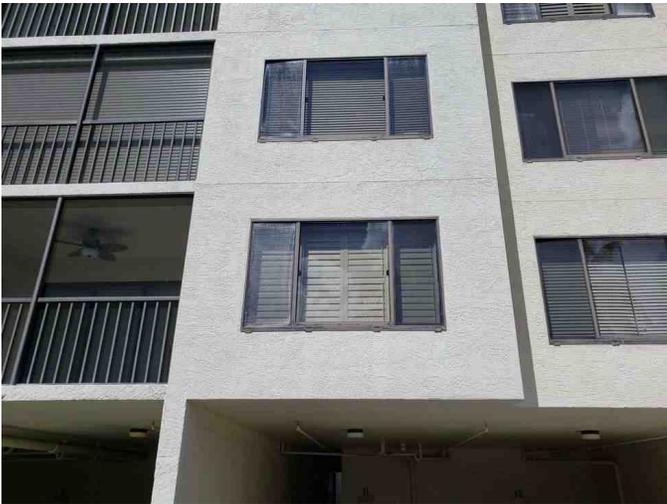
N	Opening Protection products that appear to be A or B but are not verified						
	Other protective coverings that cannot be identified as A, B, or C						
X	No Windborne Debris Protection	X				X

Unprotected Window
