May 15, 2024

Re: Santa Maria II Condominium Association, Inc.
Structural Integrity Reserve Study (SIRS)
7317 & 7327 Estero Blvd, Ft. Myers Beach, FL 33931
UES Project No: 6011.2400060.0000

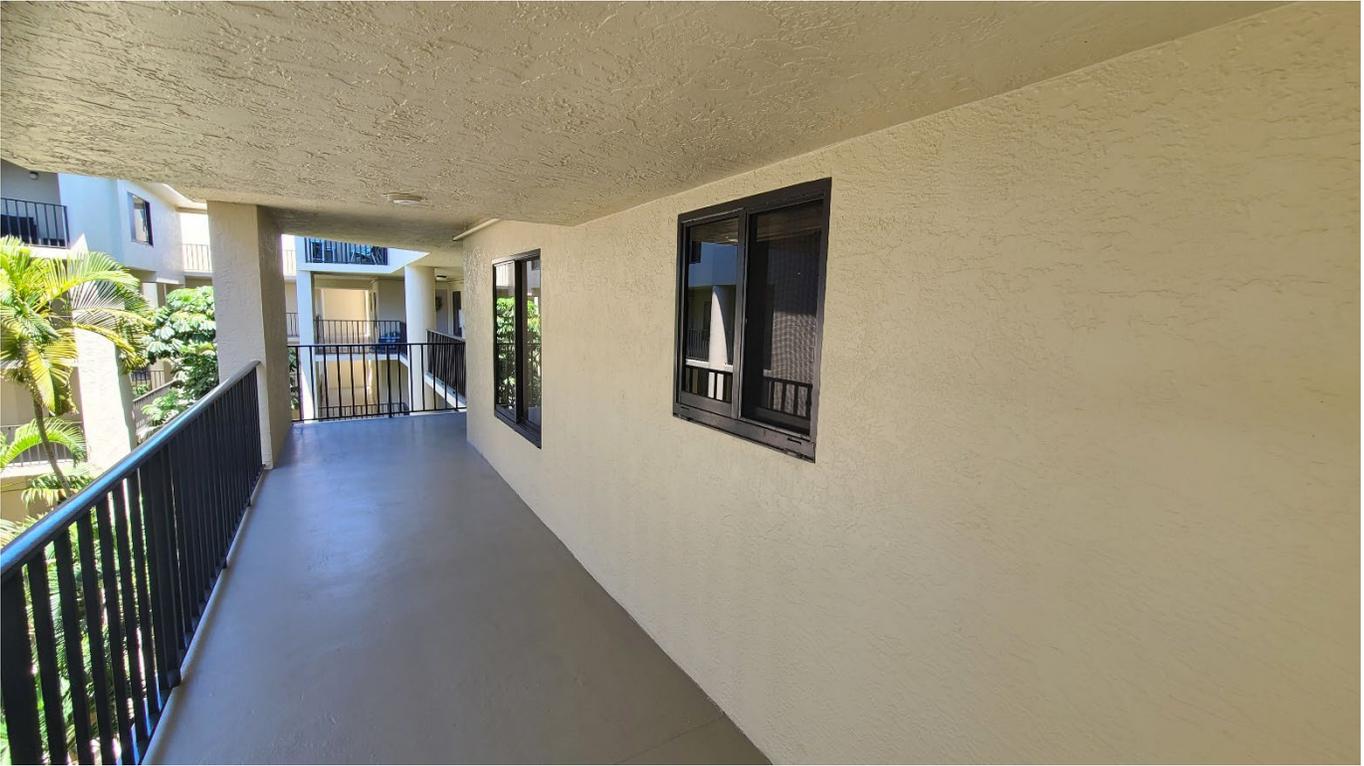
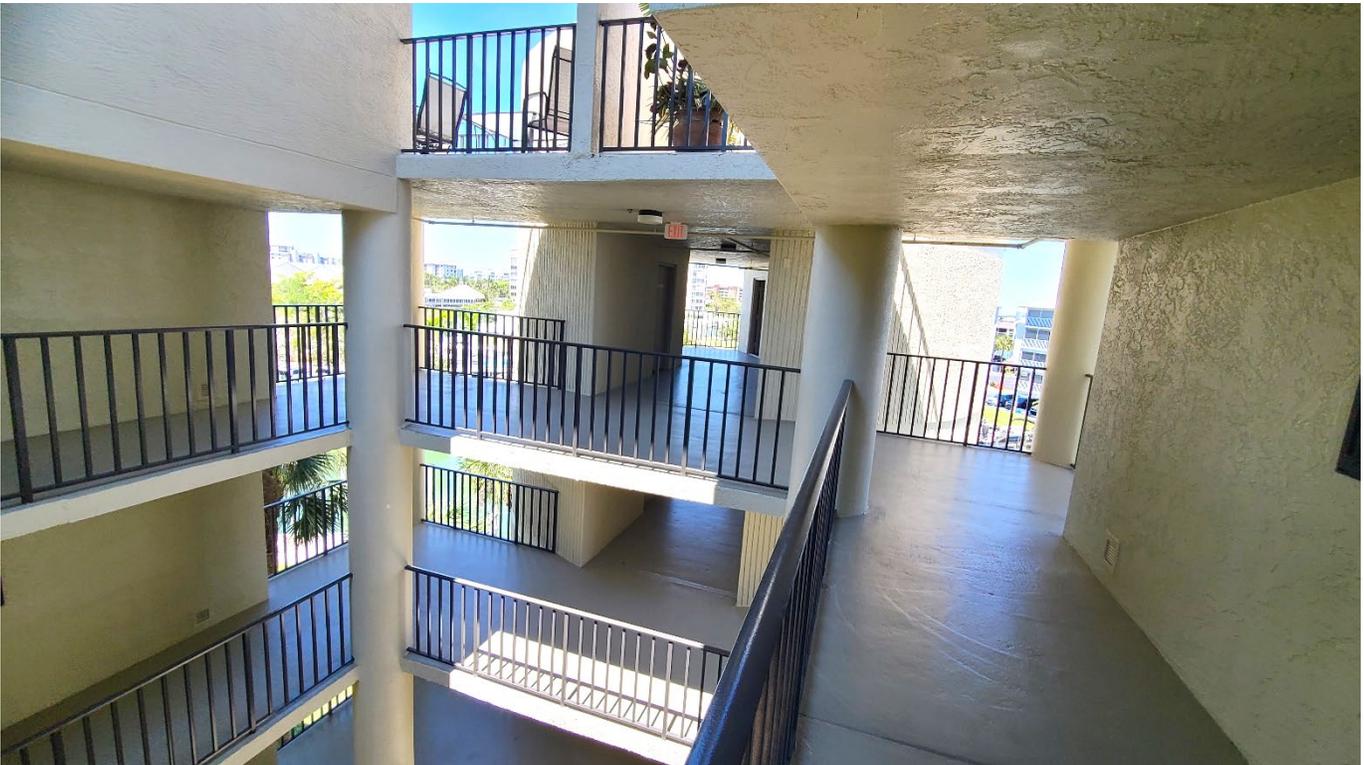
Photograph 18: Building Central Walkways

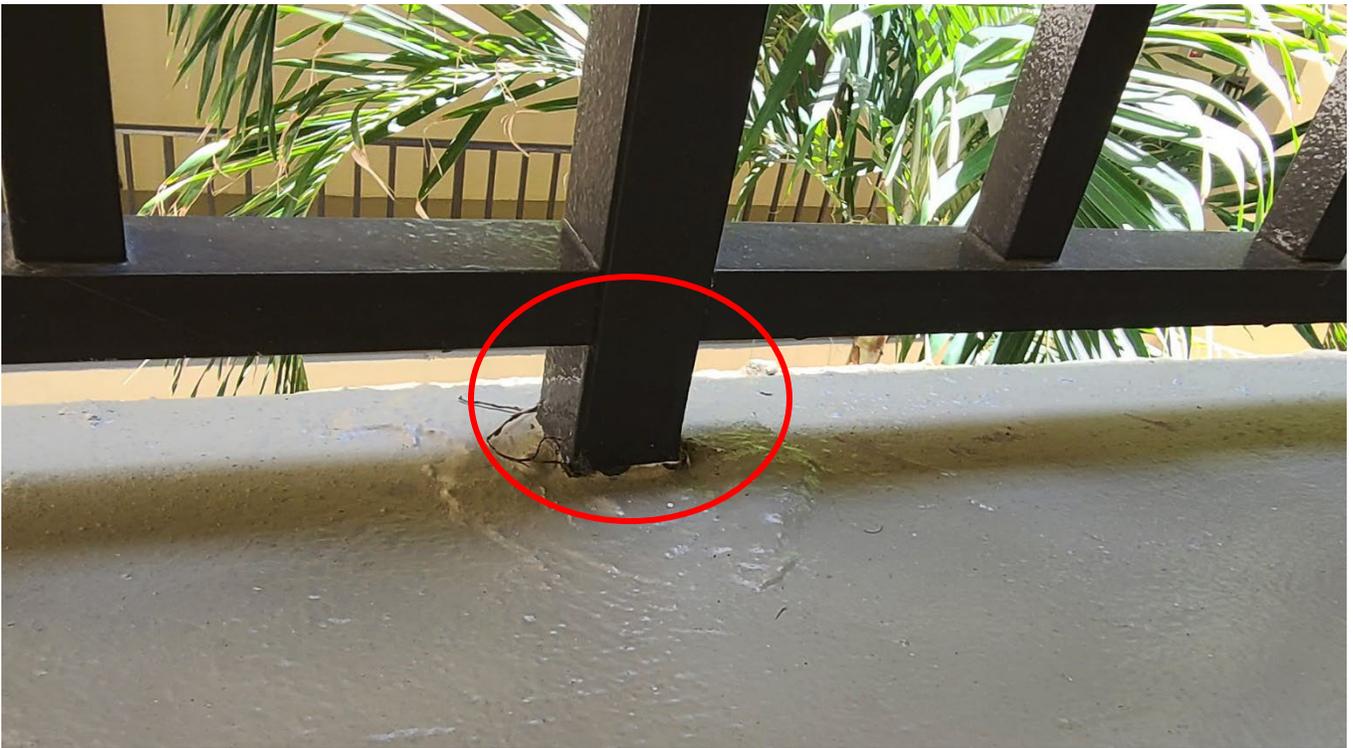
Photograph 19: Walkway Guards, Lack of Weep Holes at Bottom of Posts

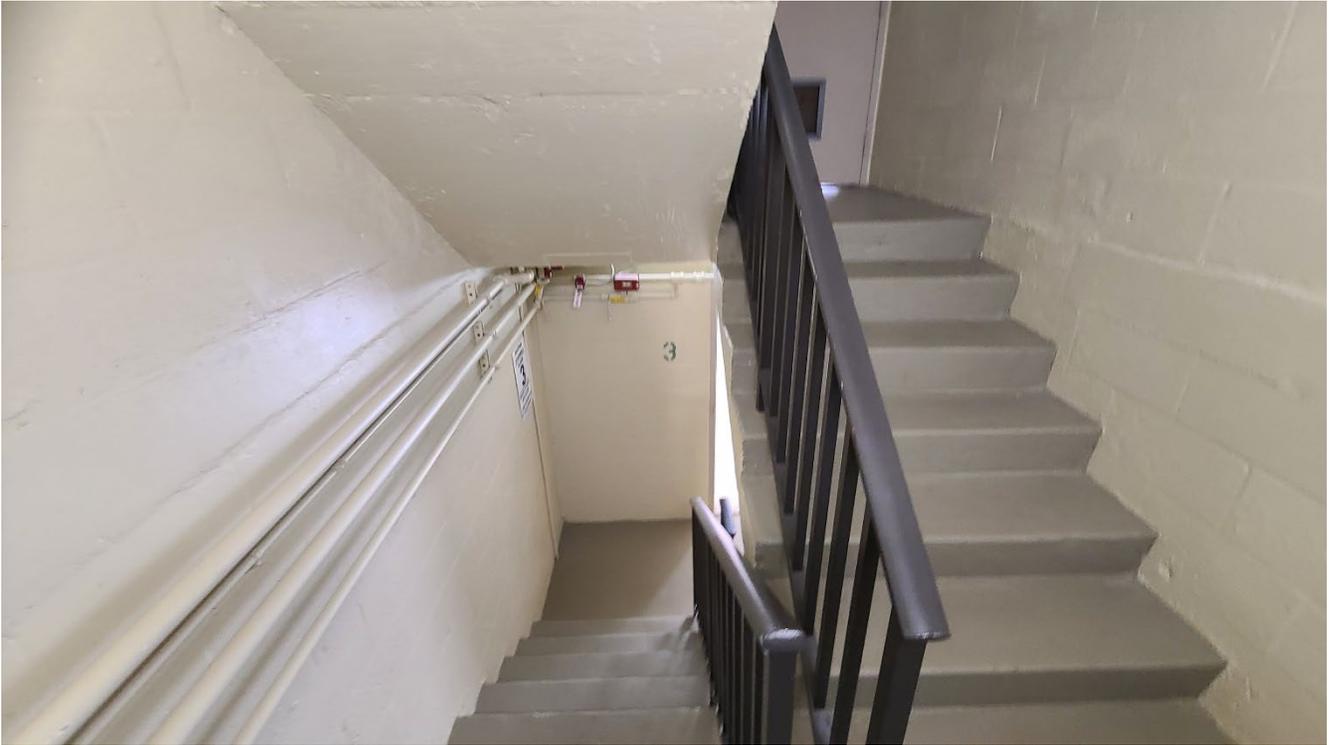
Photograph 20: Central Staircase, Current Condition.

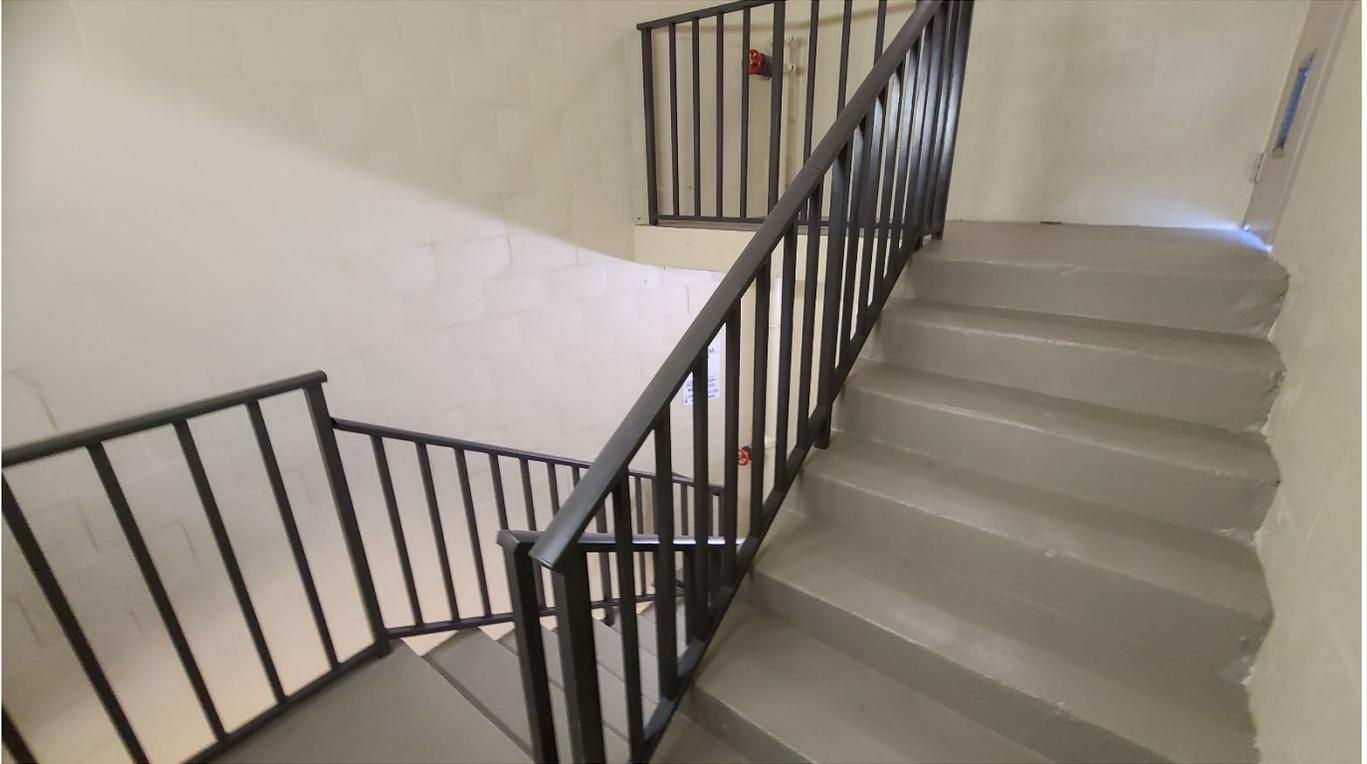
Photograph 21: South Stairwell, Current Condition.

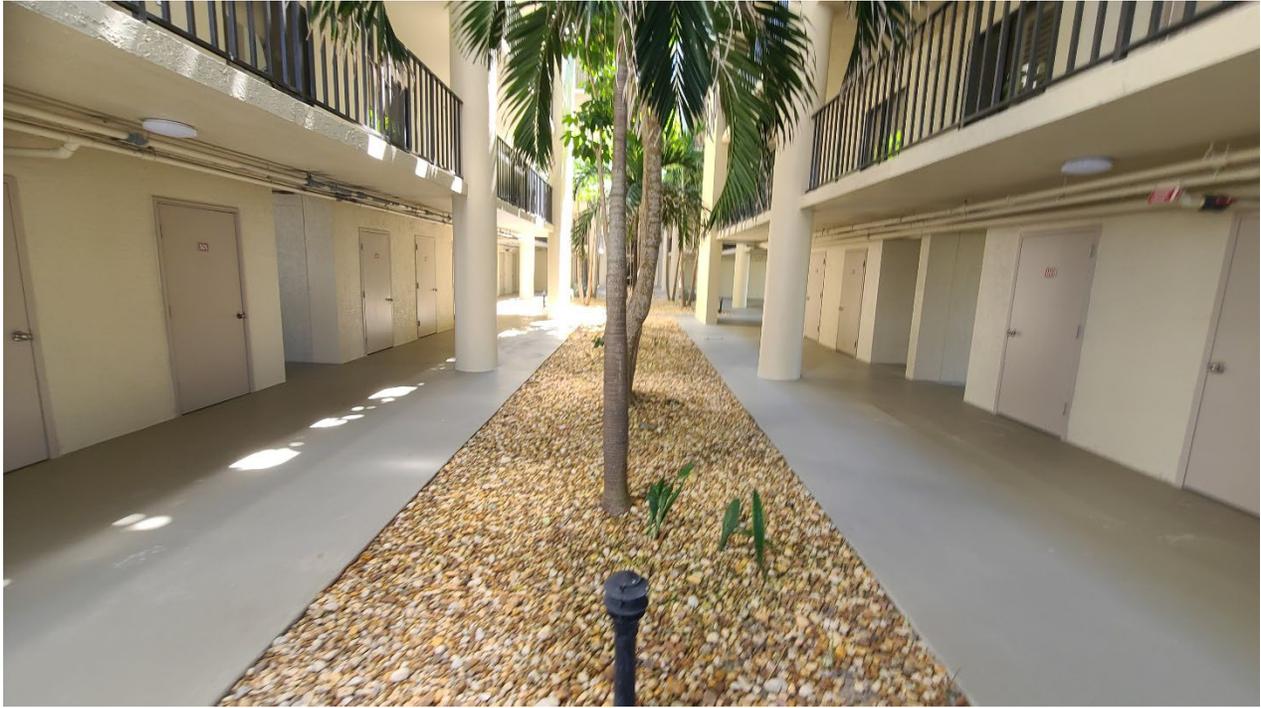
Photograph 23: Building Common Areas, Ground Level Storage Rooms, Current Condition.

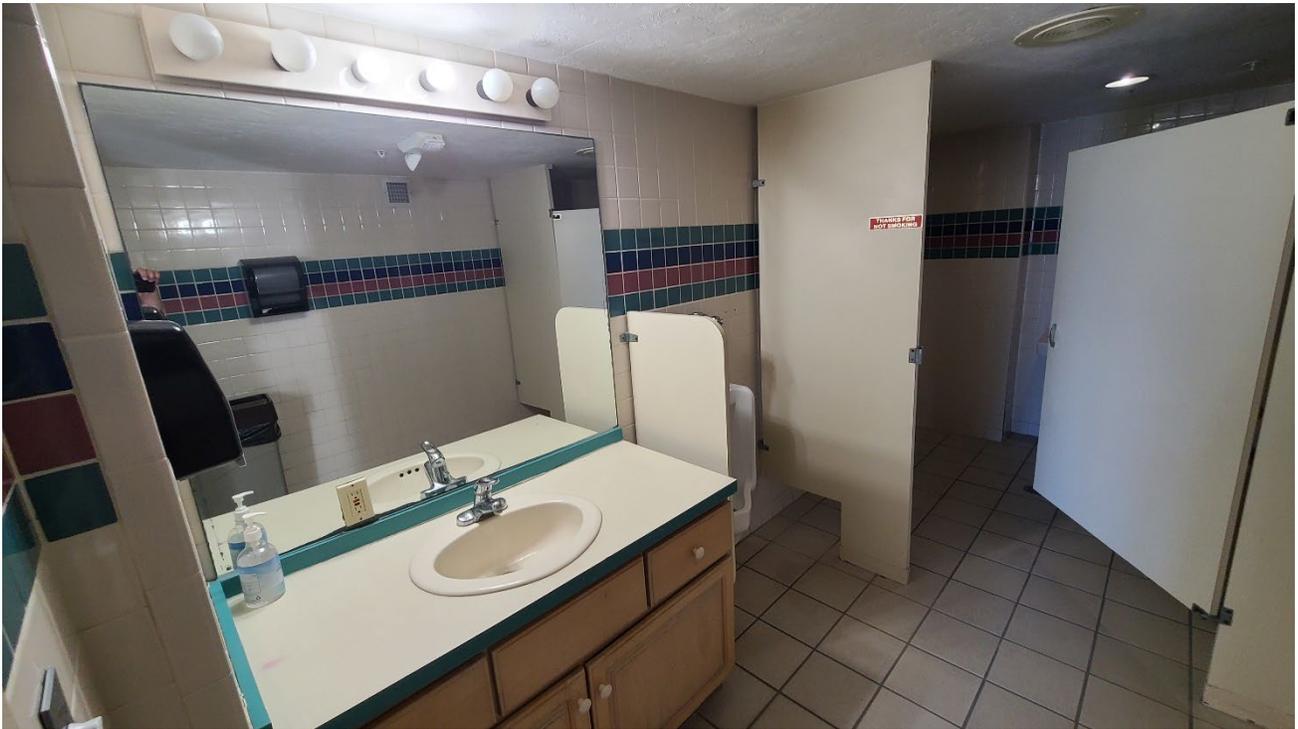
Photograph 24: Building Common Areas, Men Restroom, Current Condition.

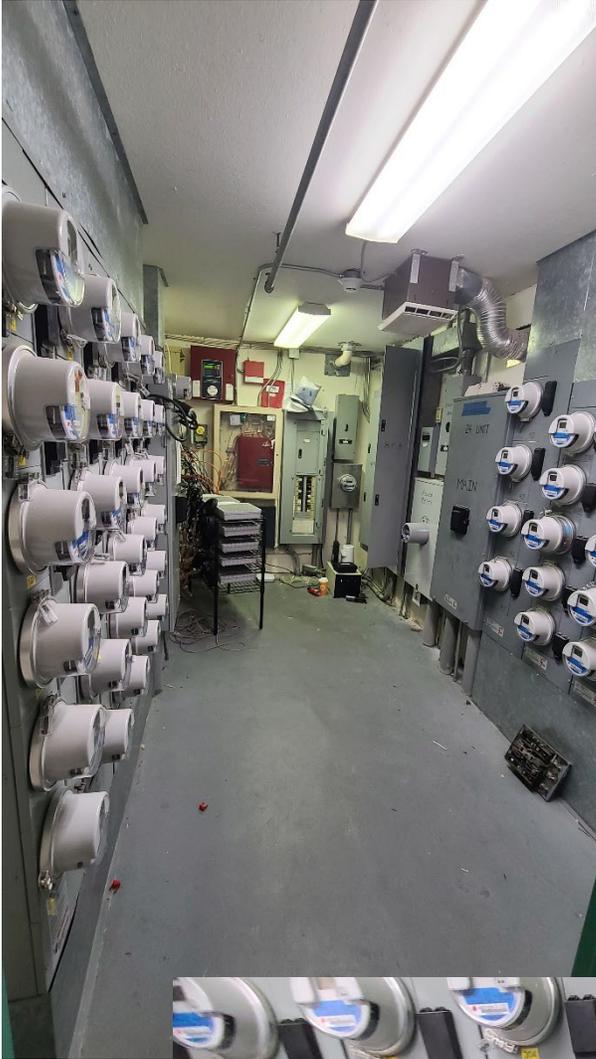
Photograph 25: Building Common Area, Power Room,
Current Condition.

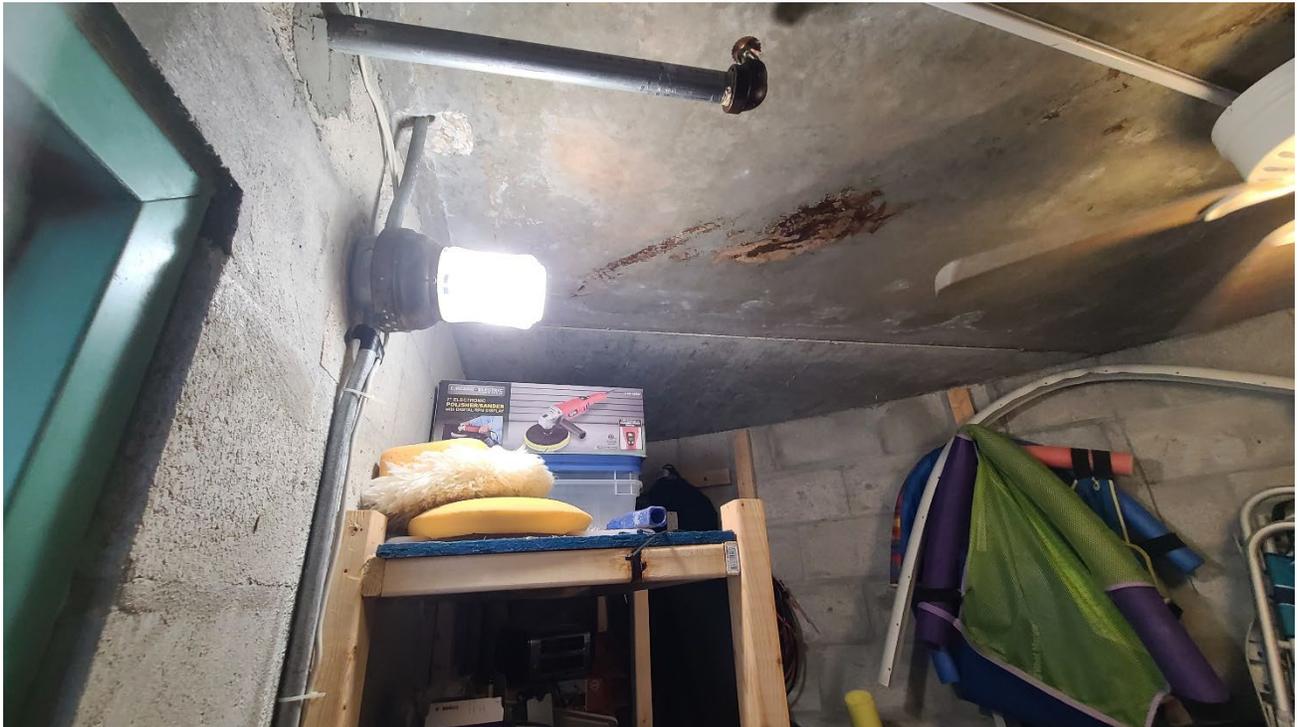
Photograph 28: Building Common Area, Inside Storage Room #13, Current Condition

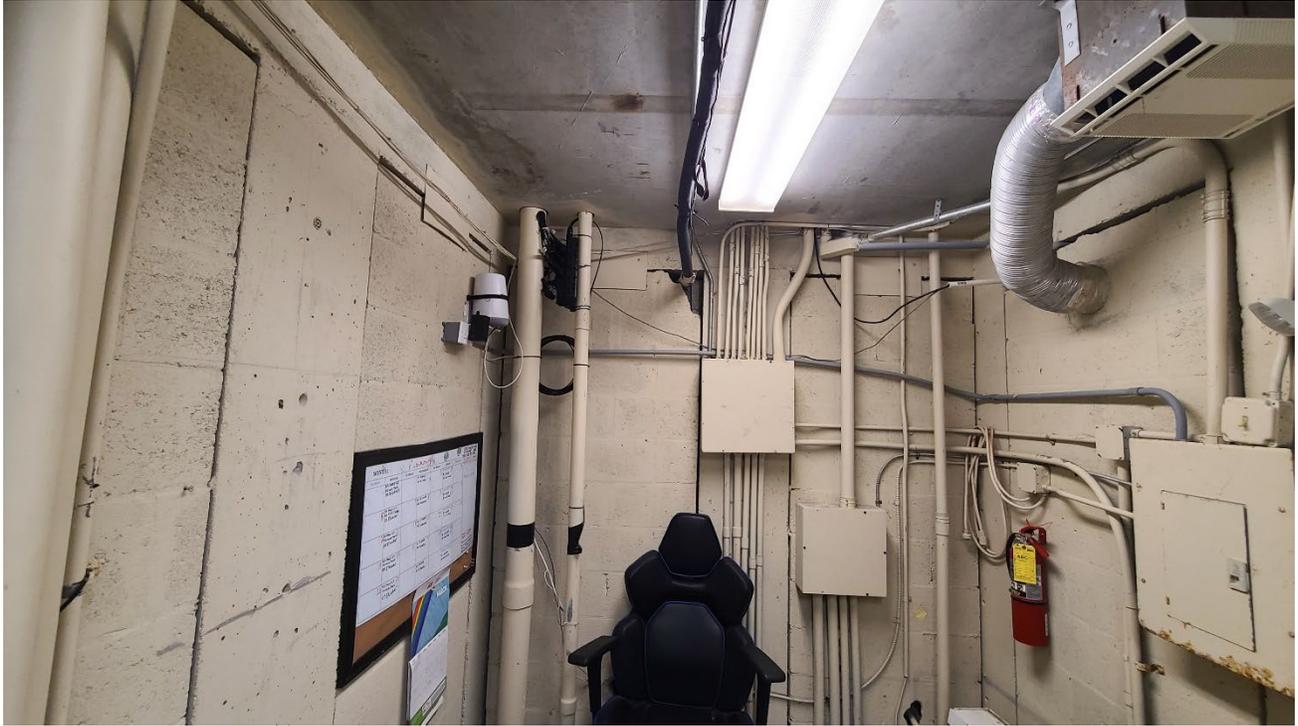
Photograph 29: Building Common Area, Inside Maintenance/Office Room at Ground Level, Current Condition.

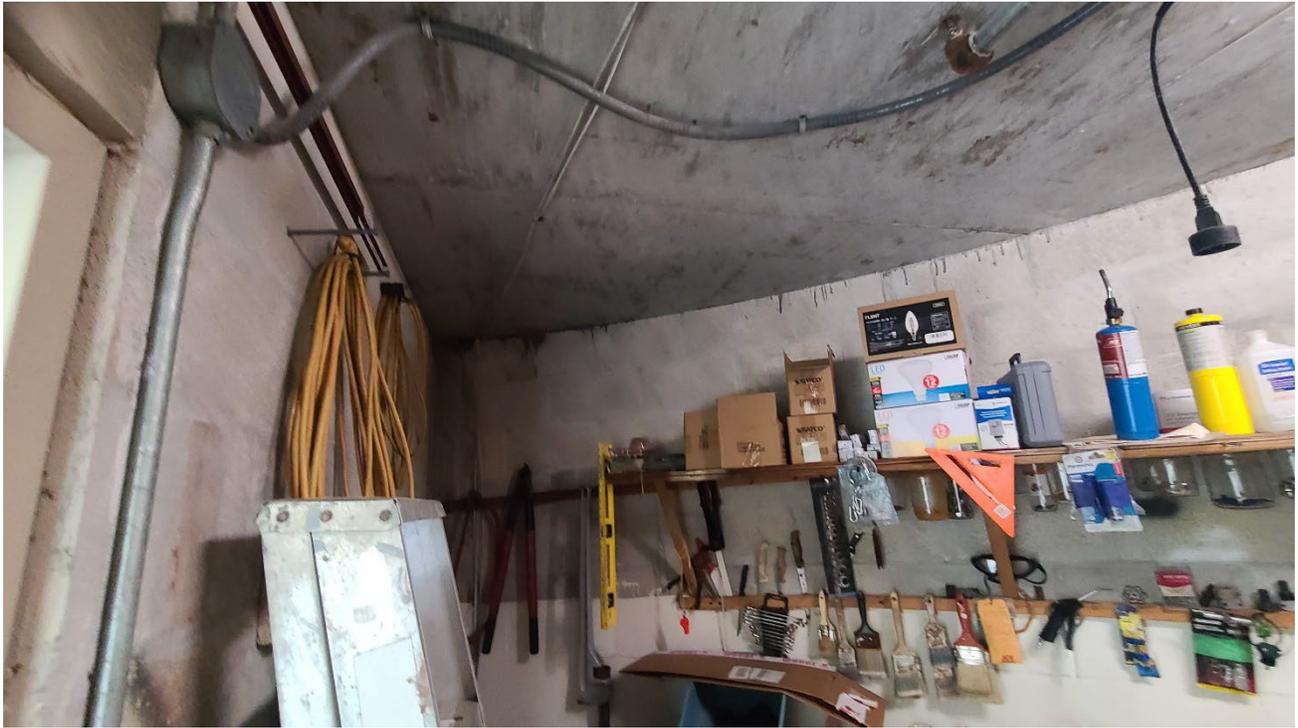
Photograph 30: Building Common Area, Inside Maintenance at North Stairwell Ground Level, Current Condition.

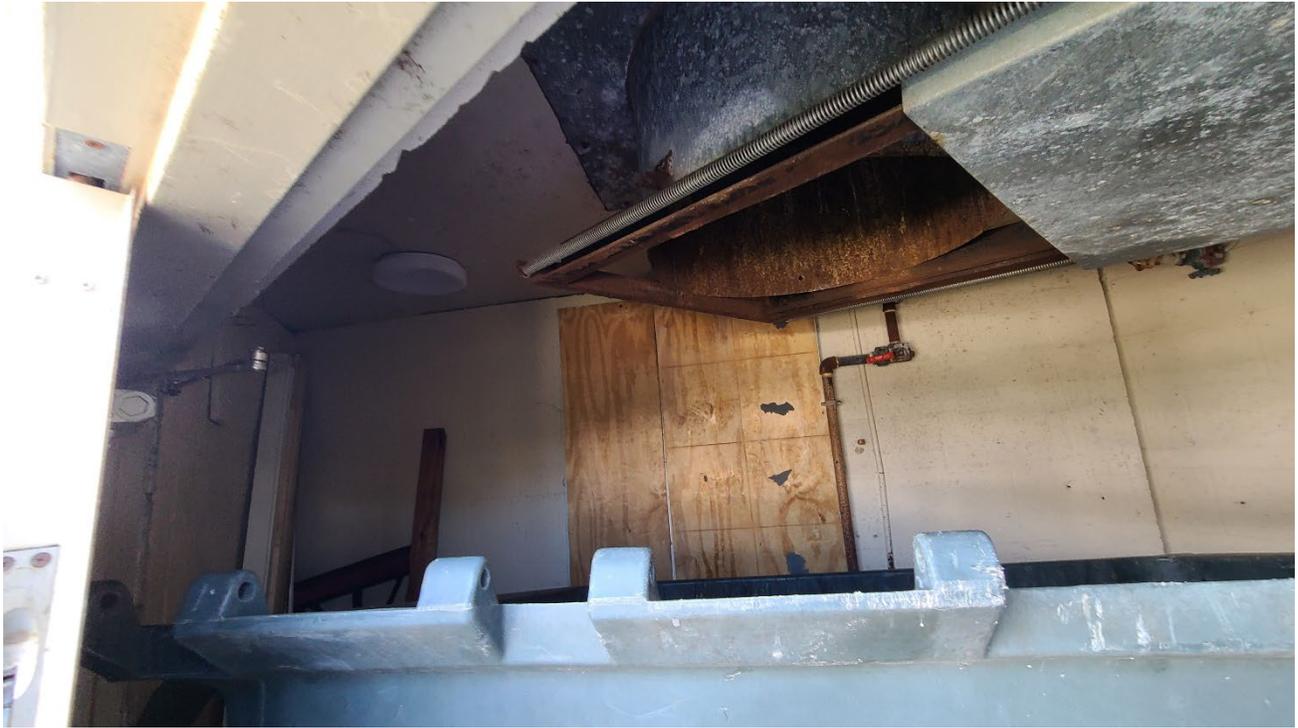
Photograph 31: Building Common Area, Dumpster Room at North Stairwell Ground Level, Current Condition.

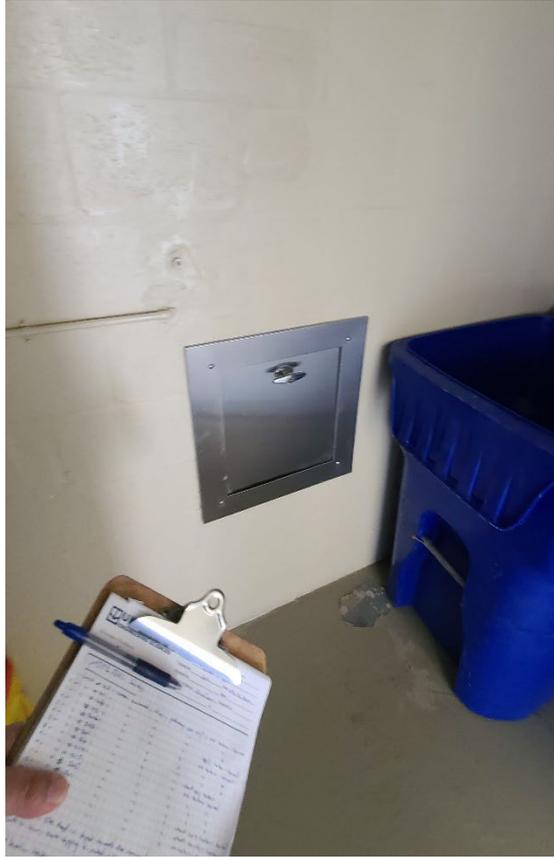
Photograph 33: Building Common Area, Trash Chute at Walkways, Current Condition.

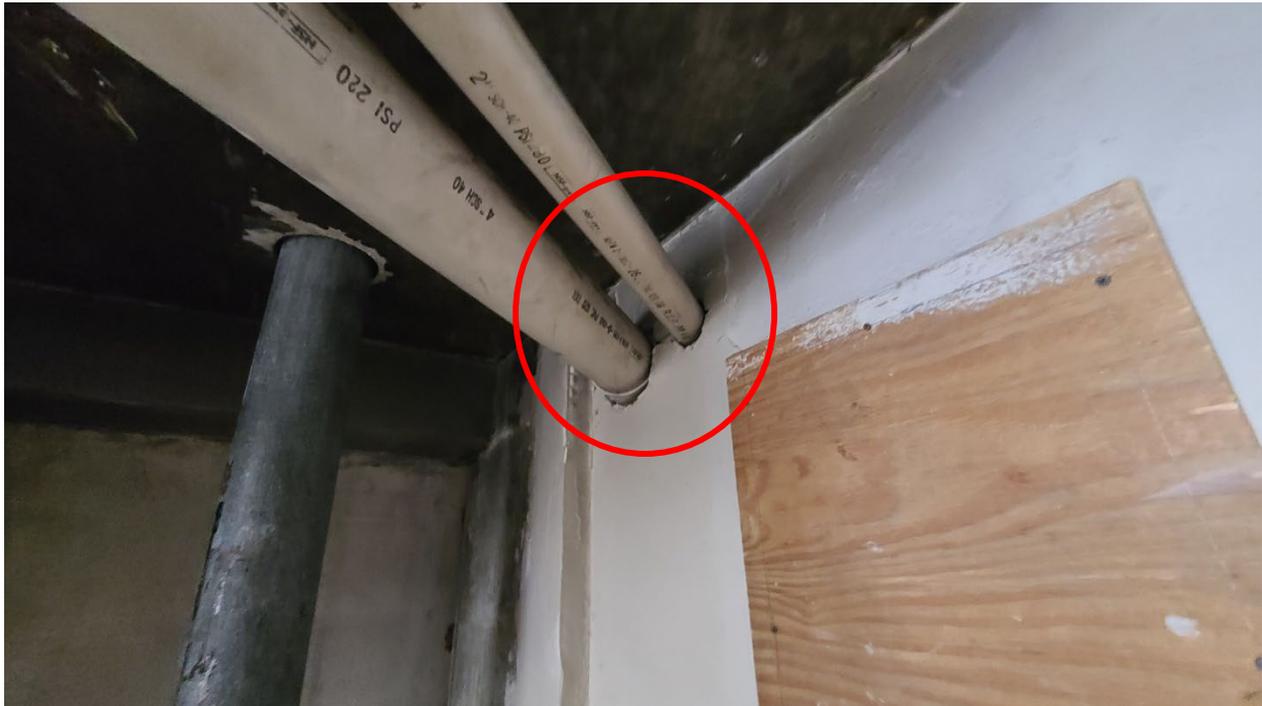
Photograph 37: Building Common Area – Example of Lack or Fire Rated Sealant at Wall Penetrations.

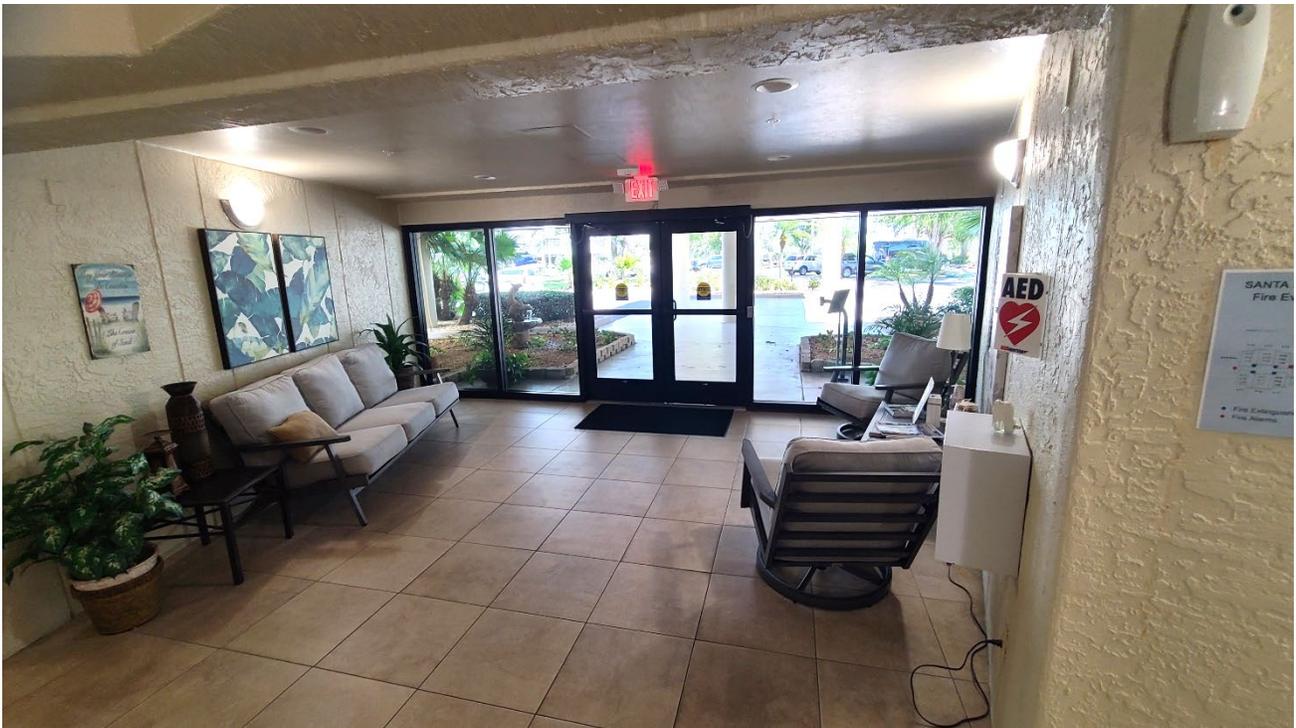
Photograph 40: Building Common Area, Main Lobby/Entrance at Ground Level, Current Condition

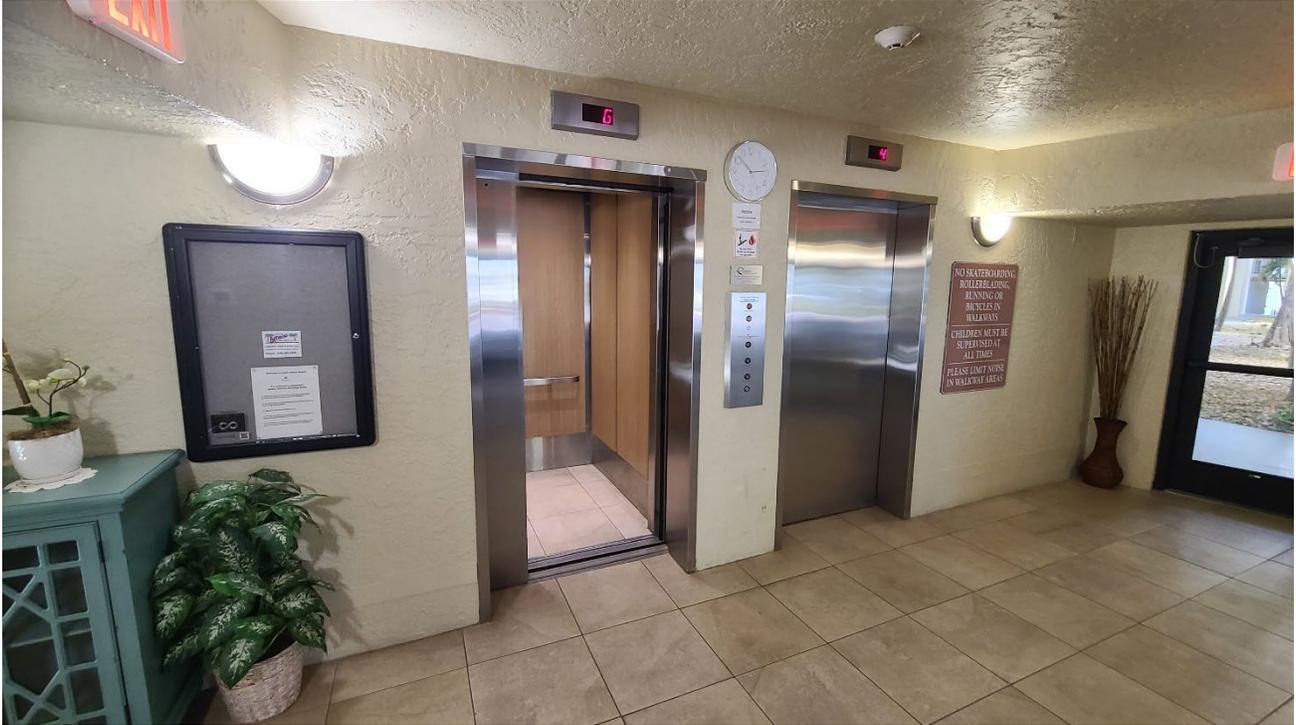
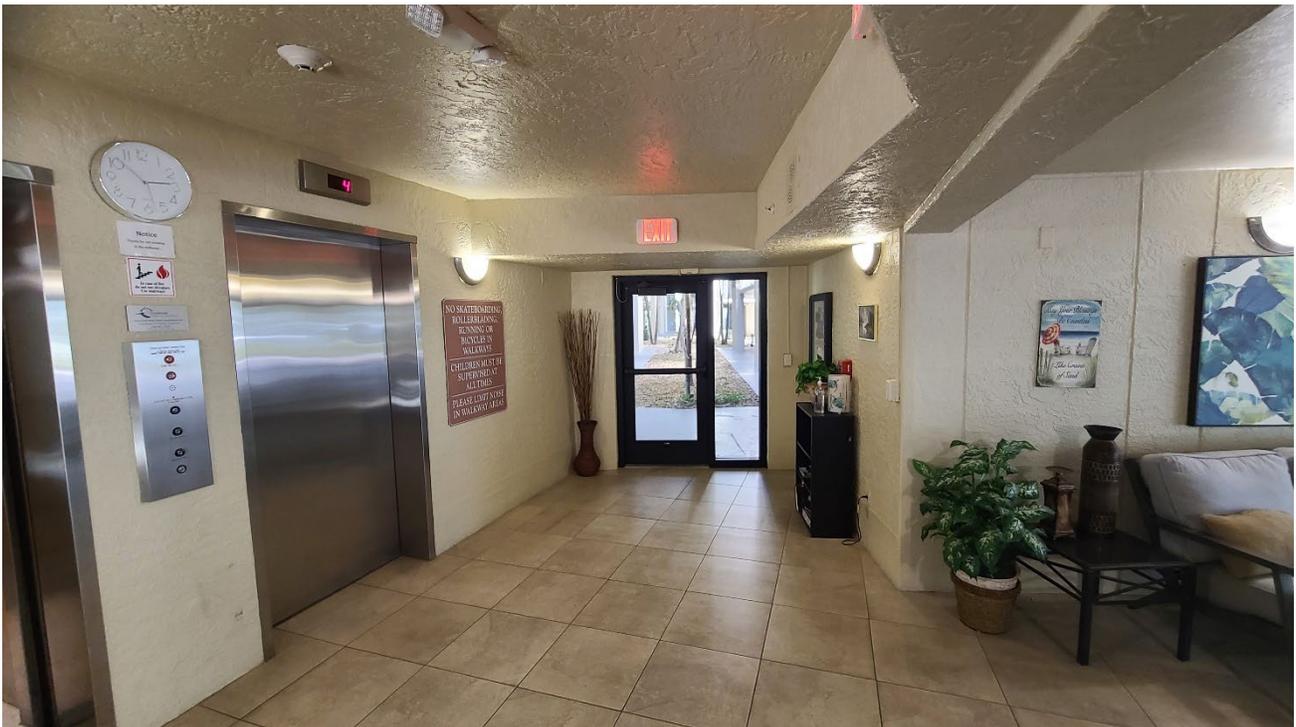
Photograph 41: Building Common Area, Main Lobby/Entrance at Ground Level, Current Condition
